Development of a new evaluation method for the influences of catalyst fines on abrasive wears of marine diesel engines burning heavy fuel oil

T.Yamada, T.Fuji, and H.Ukai
Customer support department
Diesel United, Ltd.

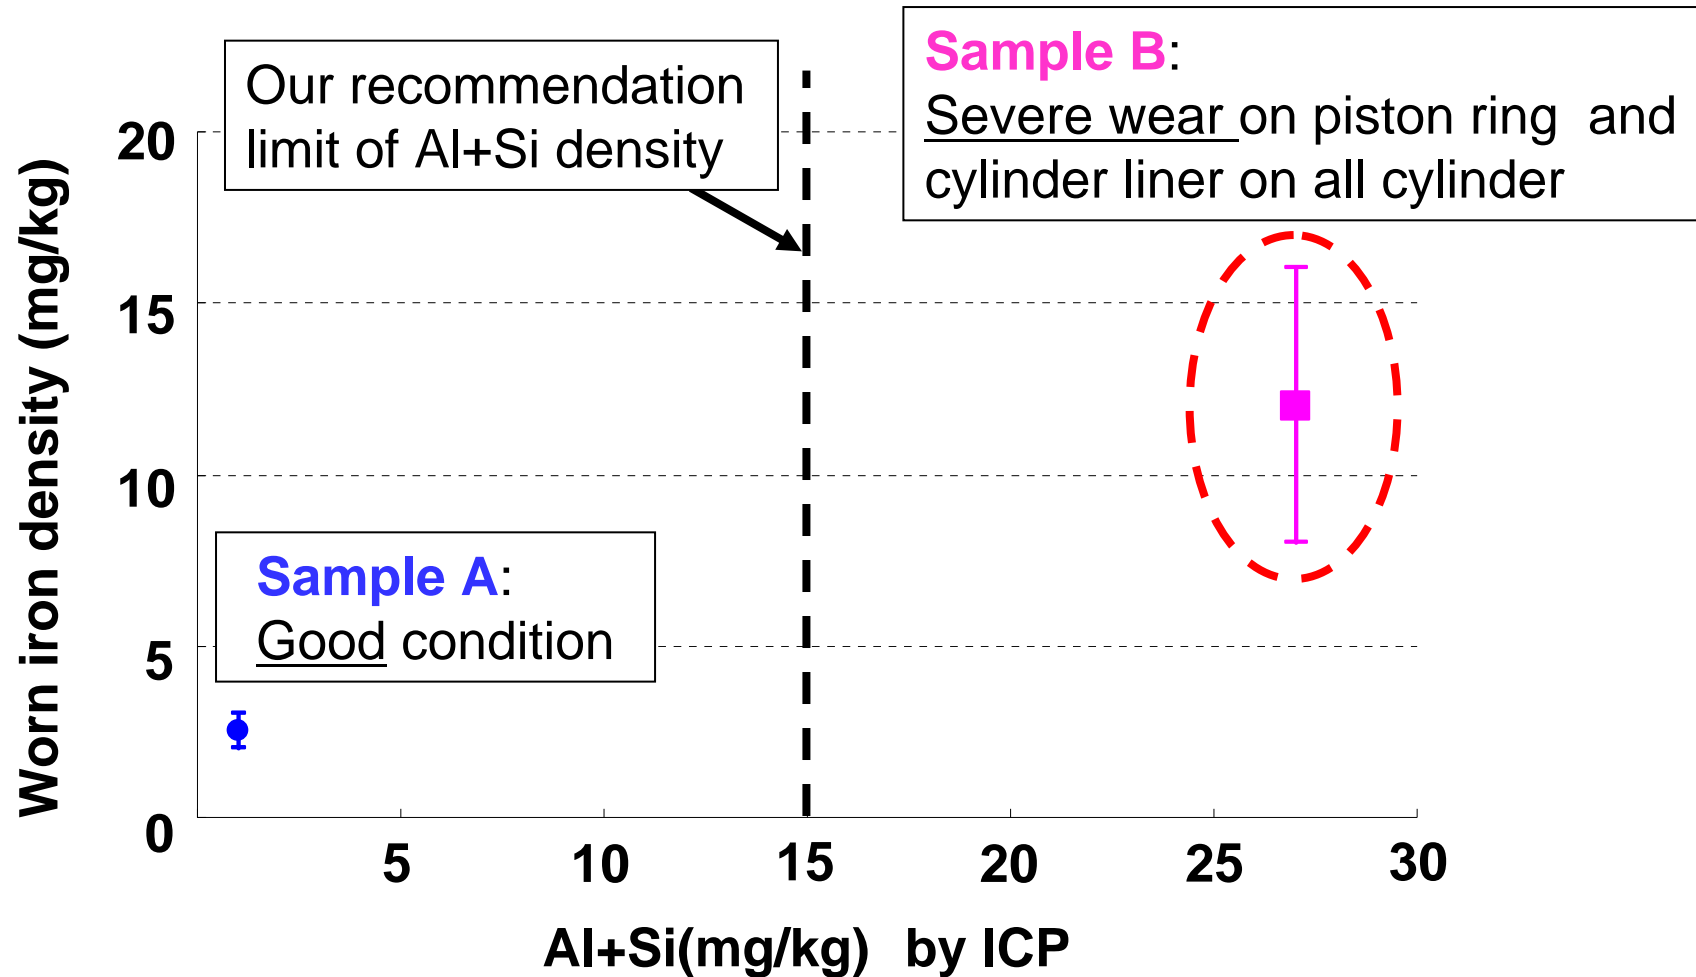
Case1. Result of high Al+Si density HFO which have high risk of abrasive wear

Worn iron density is definitely high by troubled HFO.

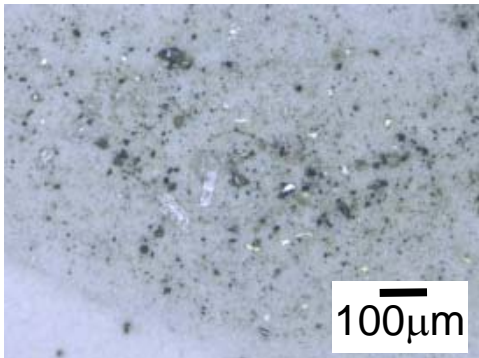
Microscope picture of particles in sample C HFO

We found some FCC catalyst fines and particles in the HFO.

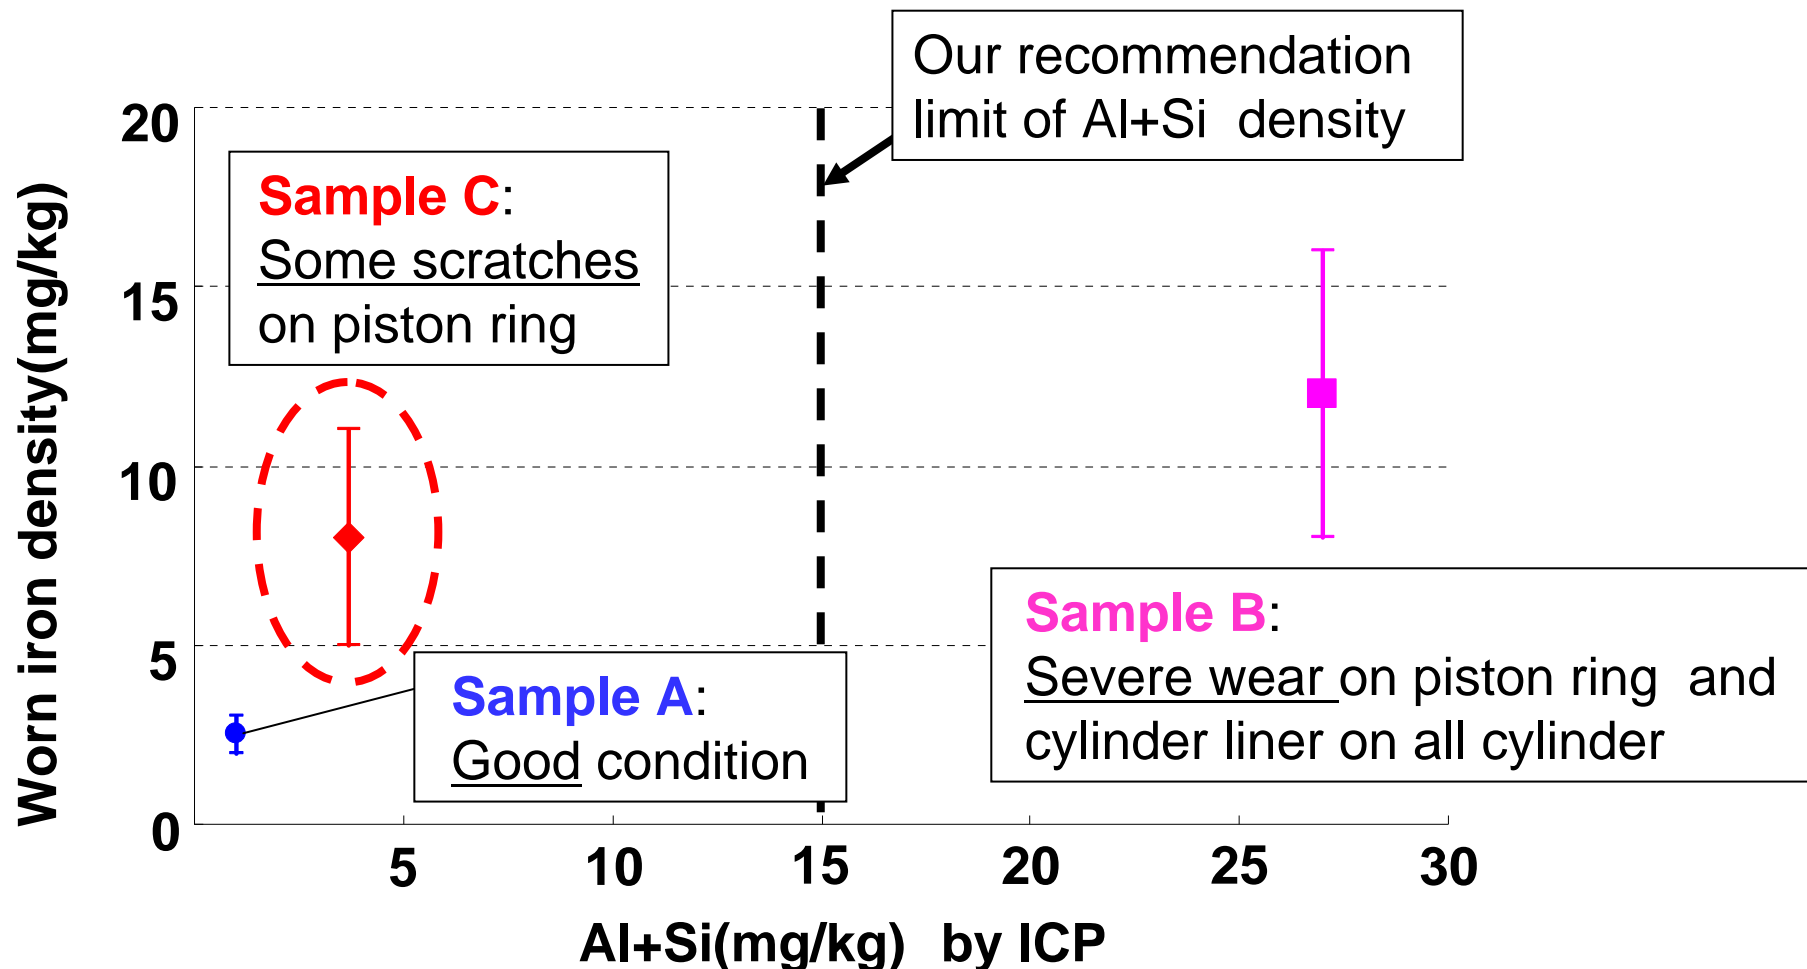
Case2. Result of low Al+Si density HFO which have high risk of abrasive wear.

Worn iron particle density correspond to piston ring and cylinder liner condition.

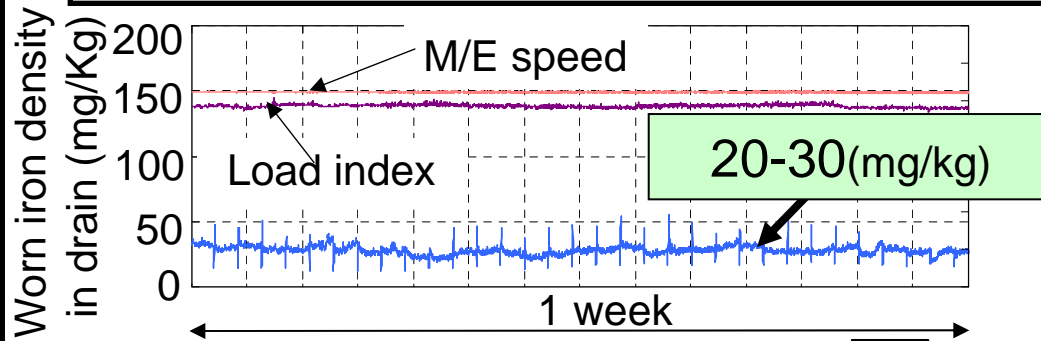
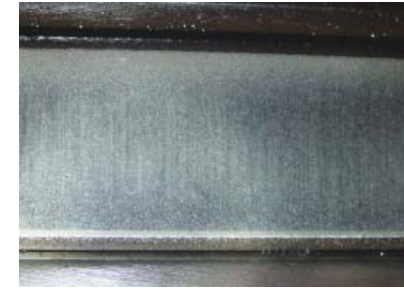
Normal worn iron density in drain and good condition on piston ring.

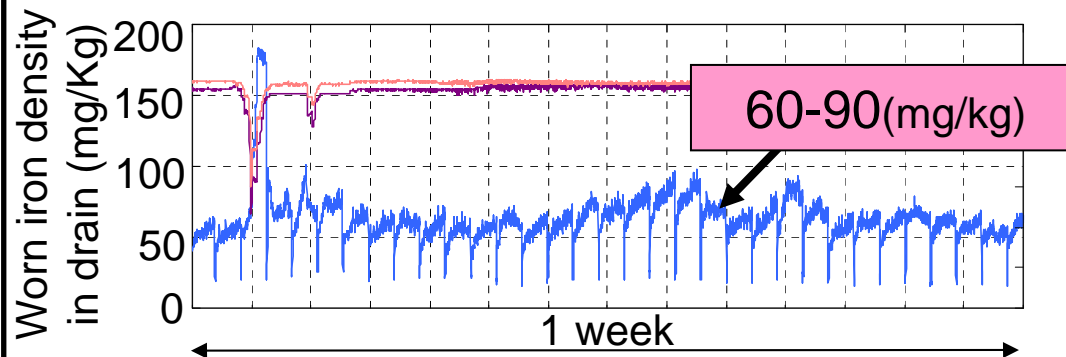
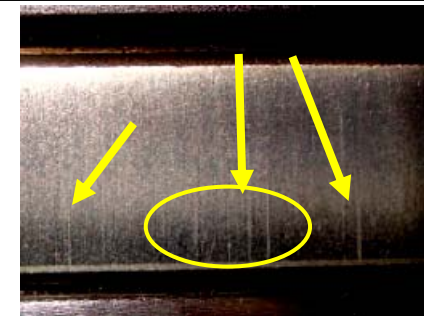
After 800 running hours

It changed to **sample C HFO** that Al+Si density is **3.7 mg/kg** at engine inlet.

Worn iron density increased, and scratches were observed on piston ring.

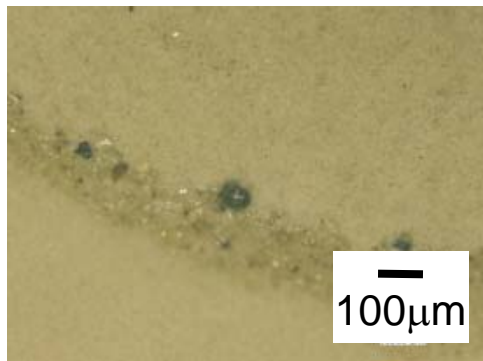
Microscope picture of
particles in sample B HFO

We found some particles in HFO,
but **FCC catalyst fines weren't found.**

The example shows that **not only FCC catalyst fines but also hard particles in HFO can cause abrasive wear.**

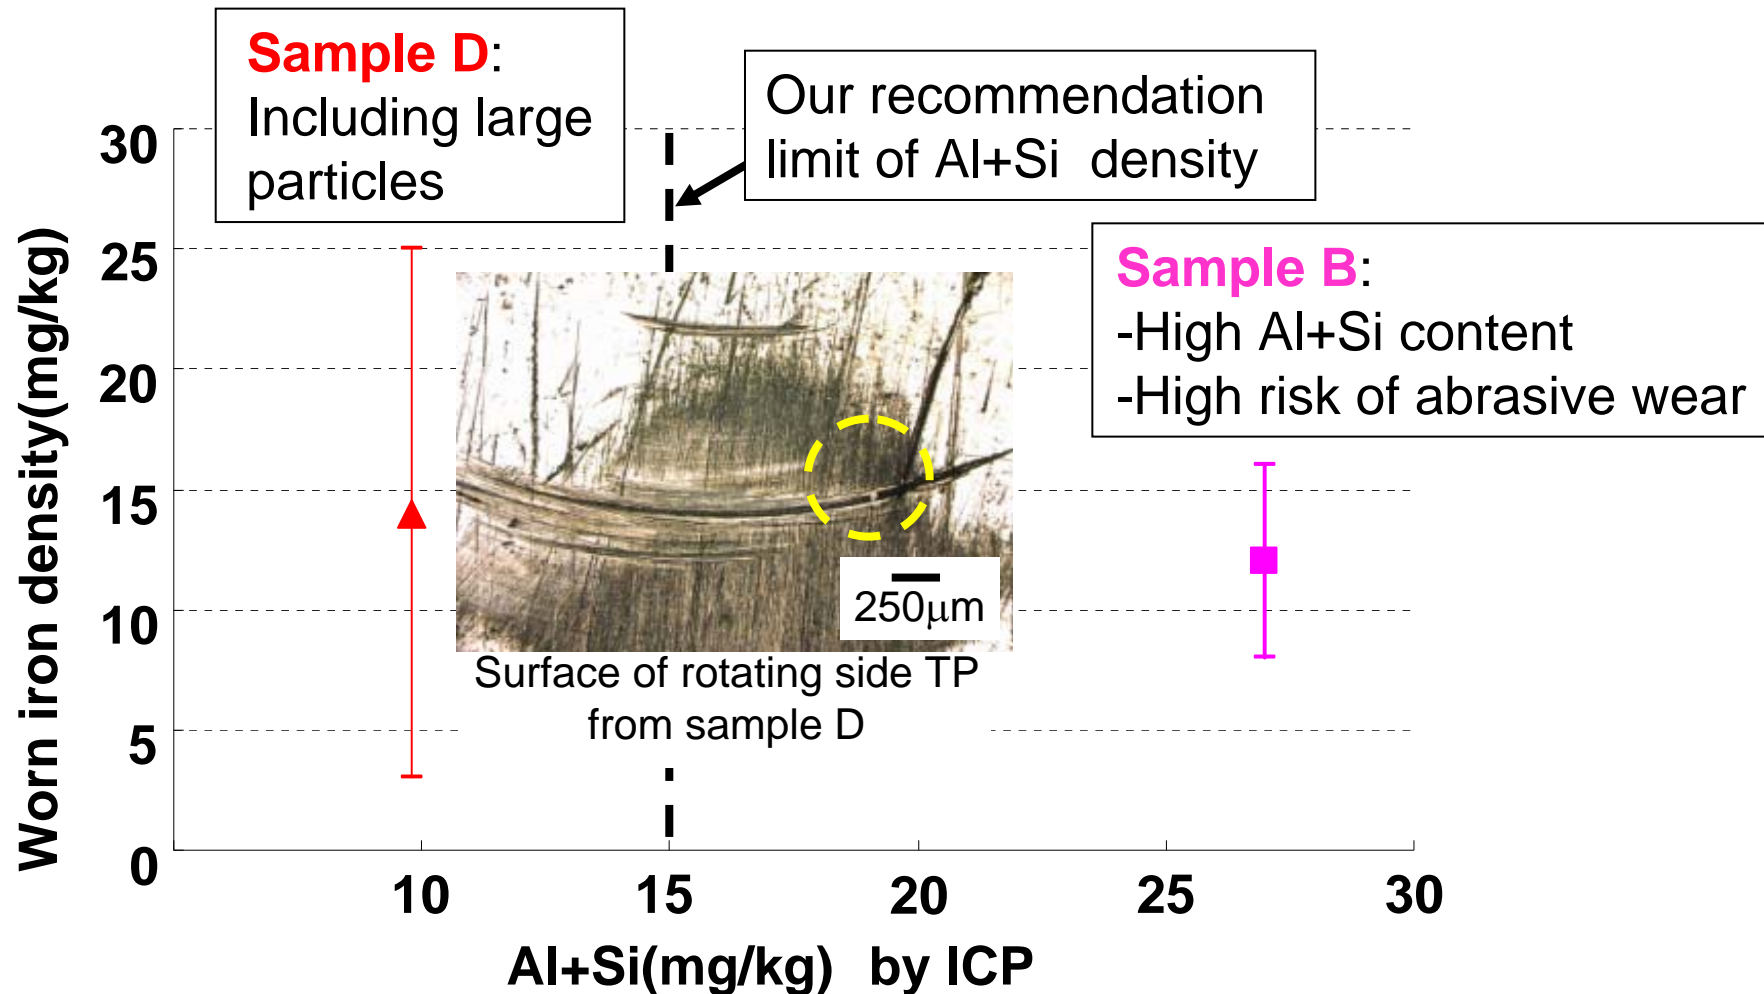
Case3. Result of HFO include large particles

High risk of abrasive wear of HFO including large particles

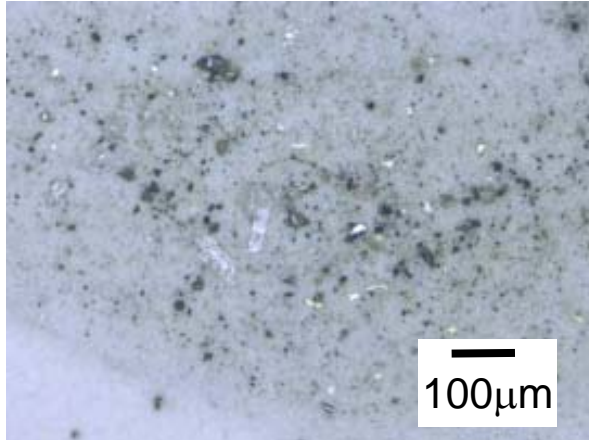
Sample B heavy fuel oil

-Al+Si content: 27(mg/kg)

Sampling position: Engine inlet

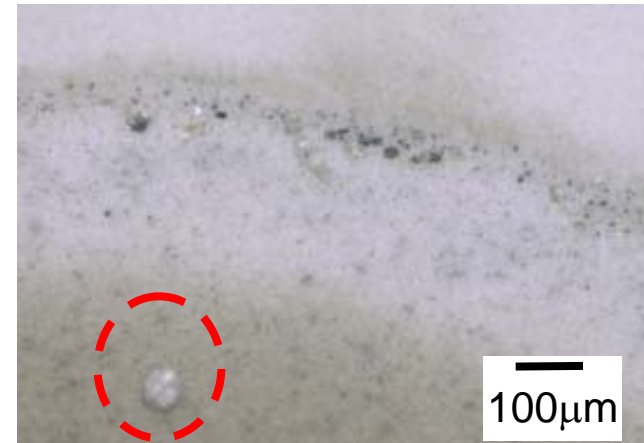
Sample D heavy fuel oil

There are some large particles in sample D, but Al+Si density is 9.8mg/kg, and it is within permissive limit.

-Al+Si content: 9.8(mg/kg)

- Higher risk of abrasive wear

Sampling position: Before purifier
