# Report on Rehabilitation Project of the “Binh Bridge” in Vietnam

“Binh Bridge,” located in Hai Phong City, Vietnam, is a cable-stayed bridge with composite girders that was completed in 2005. In July 2010, parts of the main girder and several stay cables of the bridge suffered serious damage after three ships washed away by typhoon No. 1 collided with it. Rehabilitation works on the bridge were awarded to IIA in March 2012 following a collaborative emergency investigation within the IHI Group (IHI, IIS, IIA). This is the first time IHI undertook cable replacement works and the complex stress distributions in the composite girder necessitated extensive planning. This report describes the rehabilitation works carried out on the bridge, in particular the main girder repair and stay cable replacement.

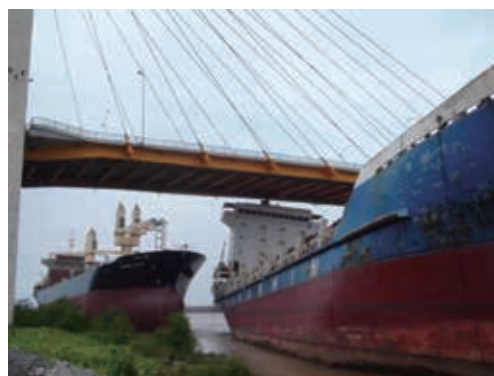
**Fig. 2** General view after ship collision

The “Binh Bridge,”<sup>(1)</sup> located in Hai Phong City, Vietnam, is a 3-span cable-stayed bridge with composite girders and a center span of 260 m that was completed in 2005. **Figure 1** shows a complete view of the “Binh Bridge.” On July 17, 2010, three cargo ships swept upstream by a typhoon collided with the bridge resulting in serious damage to the main girder and several cables. The cargo ships had been moored for repair at a shipyard near the Port of Hai Phong. They were carried approximately 600 m upstream by typhoon No. 1 that hit Vietnam that day, and collided with the “Binh Bridge.” **Figure 2** shows a general view of one of the ships’ bridges stuck on the composite edge girder after collision, and **Fig. 3** shows some of the damage to the bridge.

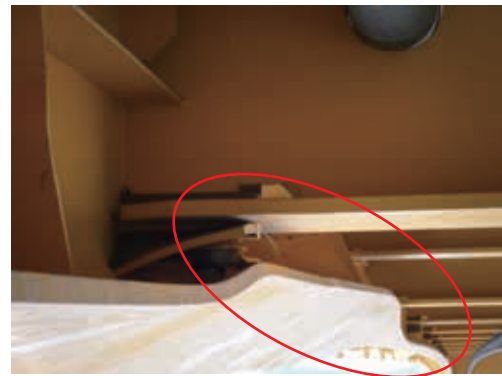
Fig. 6 Steel girder damage (inner side)

On the inner side of the girder, some of the stiffeners were completely buckled, and some of them were deformed into S-shaped forms. However, the floor beams and concrete deck slab were undamaged and sound. **Figure 5** shows the damage on the outer side of the main girder, and **Fig. 6**

shows damage on the inner side of the main girder.

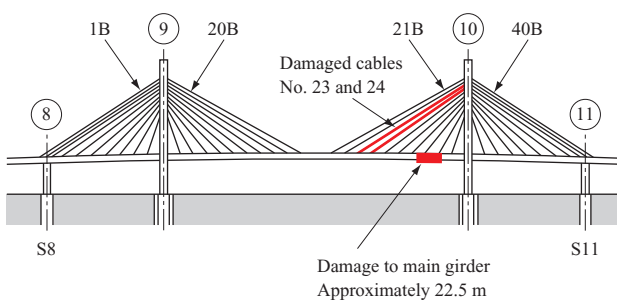
Fig. 4 Locations of damage

The main areas of damage were the bottom flange and web (approximately 22.5 m) on the downstream side, two stay cables, guard railing, and a navigation sign board. **Figure 4** shows the locations of damage.

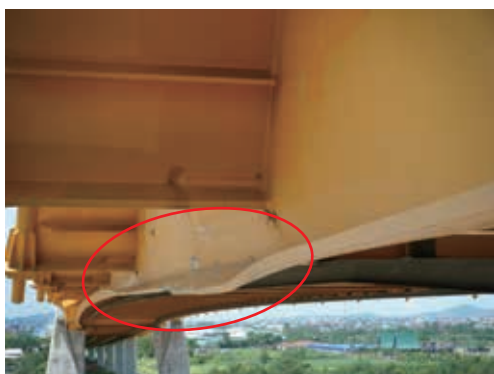
Fig. 5 Steel girder damage (outer side)

The lower portion from half of the height of the main girder web was deformed in out-of-plane direction, and the bottom flange was also deformed in out-of-plane directions.

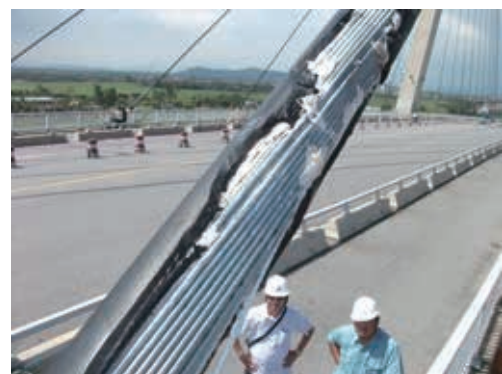
Fig. 7 Stay cable damage

The polyethylene covers (PE covers) of two stay cables were peeled off, completely exposing the wire strands which had partial damage to the galvanizing cover. White rust of the zinc coating was also observed. Judging from the state of the damage, it was obvious that salty water had gotten into the stay cable and thus the stay cable would require replacement. **Figure 7** shows the damage to one of the stay cables.

It was difficult to accurately evaluate the durability of the damaged cables, so it was impossible to guarantee their quality for the future. Therefore, we determined to replace the damaged cables with new cables.

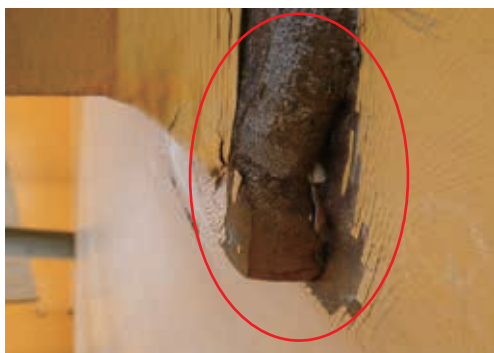
Fig. 8 Crack in web plate

The main girder was significantly bent on the bottom flange side by the collision and had residual plastic deformation. A web was pulled by the bottom flange until it developed out-of-plane deformation. The web had cracks in places near cable anchorages and was shifted by a distance nearly equal to the plate thickness (20 mm) in an out-of-plane direction. Stiffeners on the inner side of the main girder were pushed upward by the bottom flange until they were buckled, and it was impossible to replace the stiffeners. **Figure 8** shows a cracked web, and **Fig. 9** shows the buckling of stiffeners.

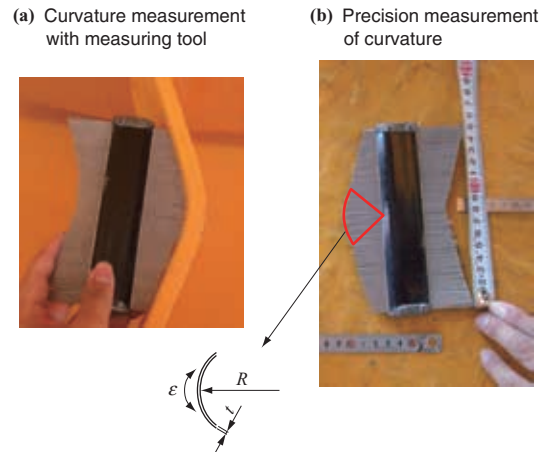
Fig. 10 Measurement of radius of bent plate

We conducted evaluation in terms of the strain of the plates with the aid of Expression (1) below. In the evaluation, we used cold bending radius  $5t$  ( $\epsilon = 10\%$ ) that is stated in the Specifications for highway bridges as a guide, in order to achieve Charpy absorbed energy higher than or equal to the required performance<sup>(2)</sup> of steel materials from the viewpoint of ensuring the toughness of steel plates. **Figure 10** shows the surface curvature of a bent plate being measured.

The simple strain evaluation by this method revealed that most portions had a strain of 3% (corresponding to a load of  $15t$ ) or lower. The strains were at levels that would not cause problems. However, our client determined to replace portions with cracks and those with apparent residual deformation anyway. The bridge portion that would be replaced is approximately 22.5 m long in the longitudinal direction

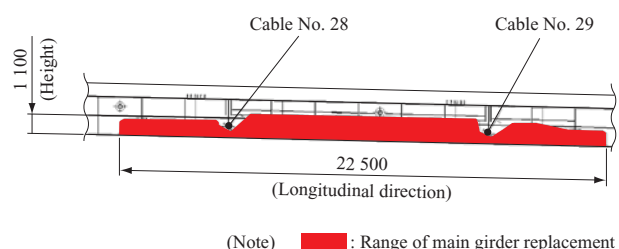
Fig. 11 Range of main girder replacement (unit:mm)

and 1 100 mm from the bottom of the main girder, which is slightly higher than half of the girder height. **Figure 11** shows the portion that would be replaced in the main girder.

Therefore, as our reinforcement policy, we determined to provide additional reinforcements ensuring sectional performance higher than or equal to the section stiffness of the main girder in a sound state, so that when the main girder was undergoing partial cutting, the section force of the cut portion and fluctuating loads would be supported. We decided to cut and replace the damaged portion under these conditions.

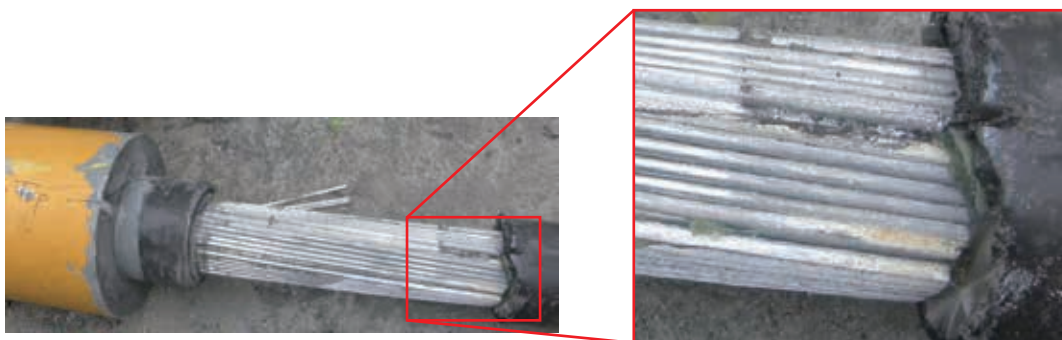
Fig. 27 Opening investigation result of damaged stay cable

In the investigation, we cut off an approximately 1.7-m long portion from the damaged cable. This portion included the 1.5-m long portion starting from the socket cap that was filled with polybutadiene rubber. **Figure 27** shows the wires of the damaged portion.

We obtained the following results from the investigation. Some portions included in the wires of the approximately 1.2-m long portion from the socket looked as though they were brand new wires. However, even in the rubber-filled portion, the development of the white rust of zinc was observed in the upper side of the cable. Brown colored portions (a small amount of red rust) were also observed. As described in **Section 3.3.2**, it is difficult to accurately evaluate the effect of corrosion on cables. Accordingly, we decided to change the damaged cables of the bridge at an early stage from the perspective of long-term safety. Our investigation of the inside of the cable revealed that some wires developed corrosion two years after the cable cover was damaged. This fact suggests that if a covered cable is damaged, the cable needs to be repaired as soon as possible to prevent moisture from intruding into the inside.
