# Initiatives for and a Case Study on Maintenance Work for Metropolitan Expressway Bridges

**KAJIMA Kenji** : Deputy General Manager, Urban Expressway Department, Bridge Engineering Division, IHI Infrastructure Systems Co., Ltd.

**MIYATA Akira** : General Manager, Urban Expressway Department, Bridge Engineering Division, IHI Infrastructure Systems Co., Ltd.

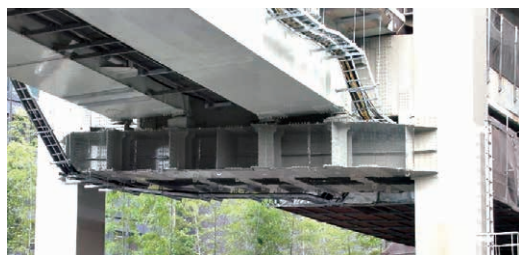
portion) became the pilot work. **Figure 3** shows the additional support beam and full-webization in the lower portion at C4060. For the attachment of an additional support beam to a round-column pier, a structure surrounding the perimeter of the round column was built. For attachment to a square column, however, we conducted a Finite Element Method (FEM) analysis for verification and adopted a structure that only connected to the surface of the column subjected to webzation. A structure for reinforcing both a square column and a box girder subjected to full-webzation with this additional support beam.

Fig. 3 Lower portion of Pier C4060 : Additional support beam and full-webzation of the box girder

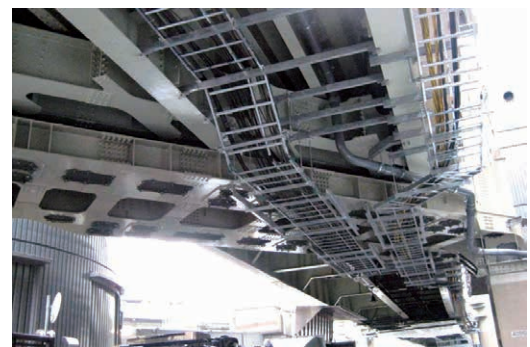
reason, additional support beams with low height (approx. 500 mm) were adopted. **Figure 4** shows a low-height additional support beam with skew angle at C4056. A box section was adopted for the additional support beams in order to ensure rigidity, and the lower flanges were provided with an opening through which works were executed. At the beam-to-column connections, which are critical parts, the beam height was increased to the extent the clearance limits were not affected, and a structure surrounding the perimeter of a square column was adopted. In addition, a reinforced notched structure, rather than full-webzation of the main girders, was adopted in order to secure space for executing works and

Fig. 4 Pier C4056 : Additional support beam with low height and a bevel angle

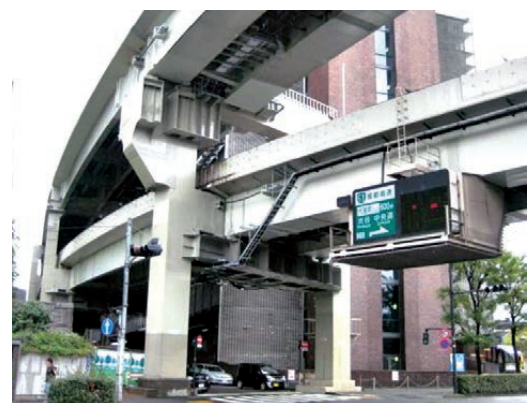
for the expressway (below the beam-to-column connection area) and implemented full-webization of the main girders. **Figure 7** shows the special support reinforcement for the upper portion at C4060. However, the notched structures of the main girders located on the expressway were reinforced and the support bracket was replaced by using temporary outriggers.

Fig. 7 Upper portion of Pier C4060 : Special support reinforcement

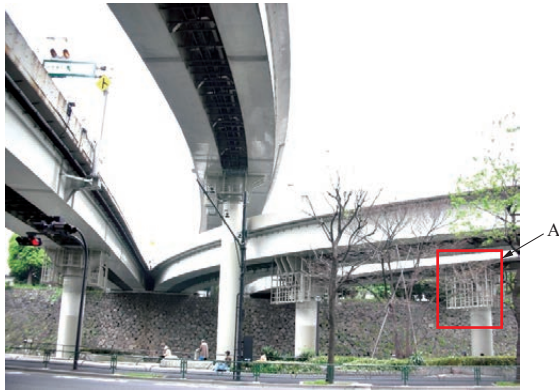
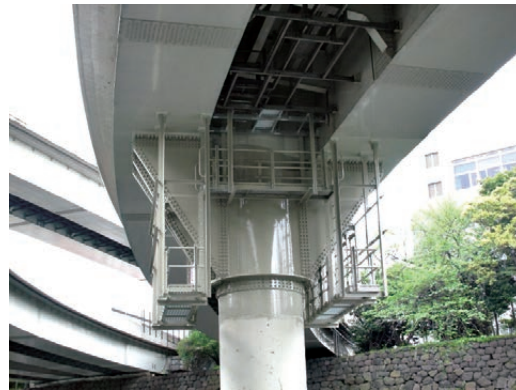
At C4061 and C4026, two main box girders and round columns constitute a rigid structure. The interiors of the beam-to-column connections are narrow with plates assembled in a special and complicated manner. In this narrow area, a number of cracks were detected. We used dynamic strain measurements taken from actual bridges and 3-dimensional FEM analyses to identify the cause and determine repair/reinforcement measures and work execution steps. Three types of reinforcement were used in combination: reinforcement called “BOOKEND” consisting of a

combination of fillets, reinforcement with a stiffening plate wrapped around a pier, and cross beam joint. **Figure 8** shows the beam-to-column connection reinforcement at C4061.

**Fig. 8** Pier C4061 : Reinforcement at beam-to-column connection

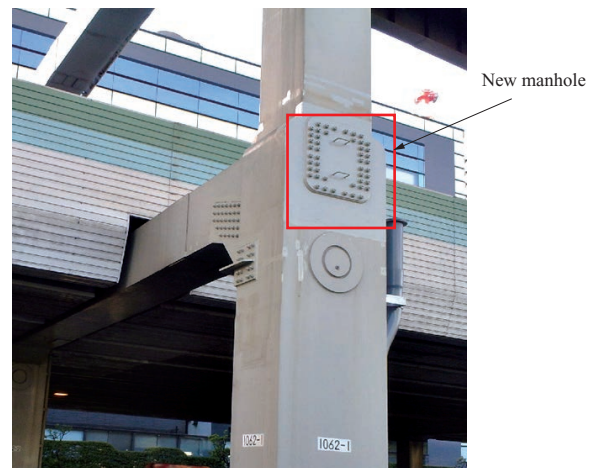
to the interior of the pier was created (Fig. 10) before reinforcement with a stiffening plate. Out of consideration for restoring the original enclosed structure after the reinforcement and for future accessibility to the interior of the pier, the manhole cover was closed with one-side bolts.

Fig. 10 New manhole

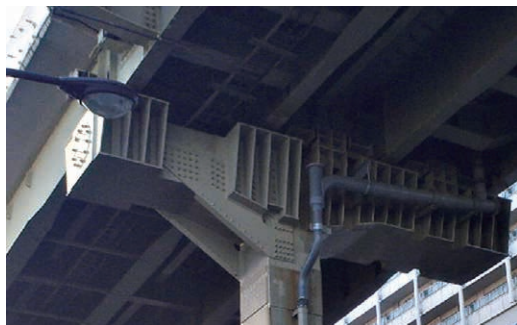
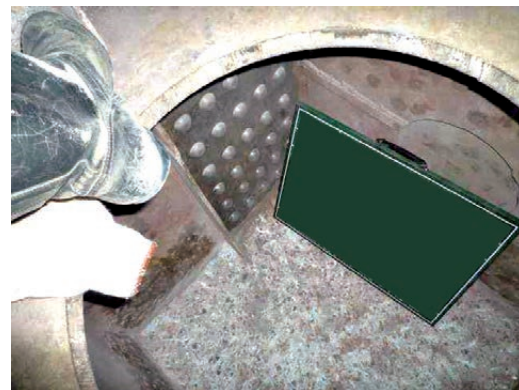
The rest of this section describes some of the cases in which there was an obstacle at a place where reinforcement with a stiffening plate was to be carried out. Where a bracket welded for displacement restriction or widening bridge pier edge was located, such bracket was removed and a stiffening plate for reinforcement and a new bracket were tightened to each other with high-strength bearing bolts in order to avoid damage to the pier (Fig. 11-(a)). Where concrete had been embedded in columns during a previous seismic resistance improvement work, the concrete was cut to install a stiffening plate, and after completion of its installation, the columns were refilled with concrete (Fig. 11-(b)).

Fig. 11 Obstacle at beam-to-column connection

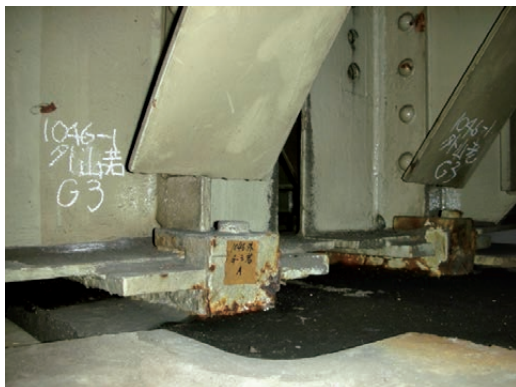
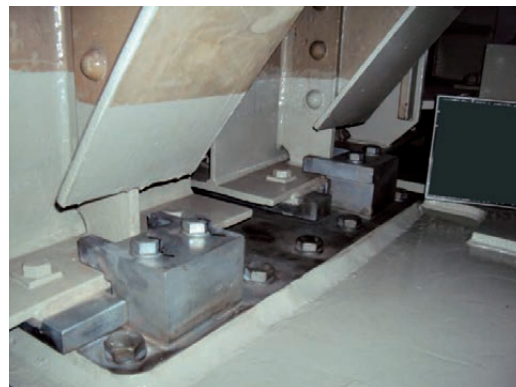
Fig. 13 Before and after replacement of bridge support

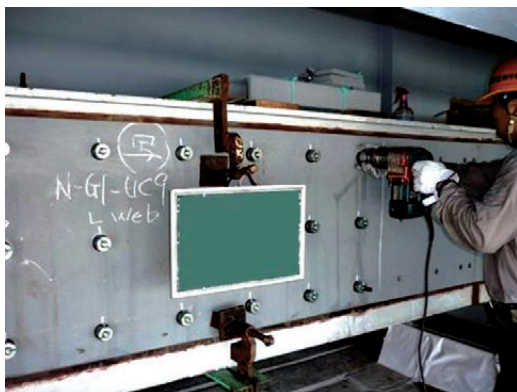
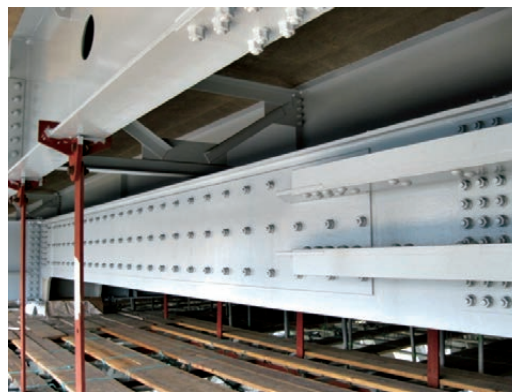
It was decided to implement reinforcements against earthquakes to ensure level 2 aseismic performance, which limits seismic damage against level 2 earthquake ground motion — the probability that this level of earthquake ground motion may occur is low during the service period of the bridge but the intensity of this motion is high — and which allows for early restoration of bridge functions. For the superstructure, we established a policy of maintaining the elastic region for primary members and to accept plasticization for secondary members and conducted design in accordance with this policy. Stiffening plates were applied to the main chord members of the truss that would be caused by an earthquake to have an elasticity exceeding the elastic limit, and bypass members were installed so that they crossed existing splice plates. **Figure 19** shows the situations before and after application of a stiffening plate.

Fig. 19 Reinforcement plate

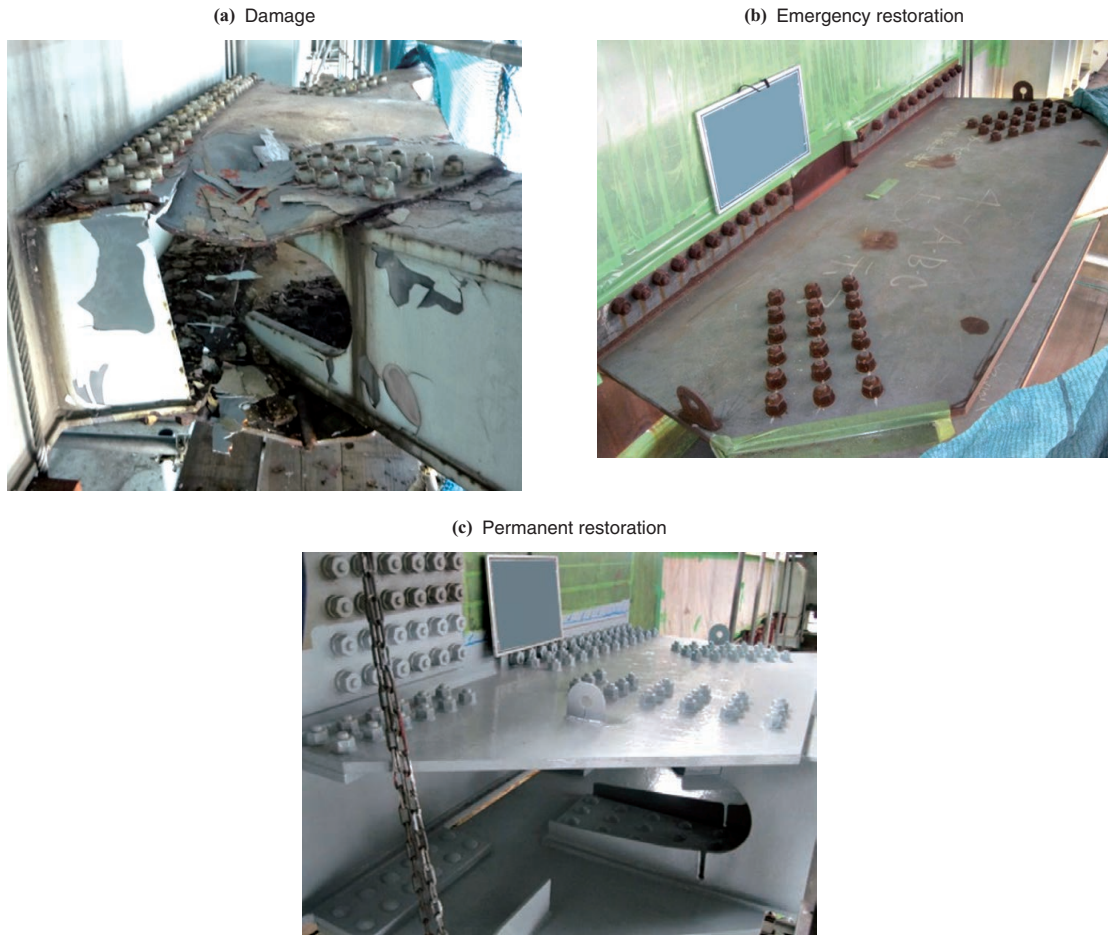
During emergency restoration, we conducted an inspection promptly after the occurrence of the earthquake in order to identify damaged parts. In addition, we determined feasible reinforcing methods through close communication with the owner and other stakeholders. Moreover, during fabrication and execution of works, we diverted materials, made structures labor-saving, and executed works on a round-the-clock basis. As a result, it took only 12 days to complete restoration, and the bridge was reopened to traffic at 3:00 a.m. on March 22. **Figure 21** shows gusset plate restoration.

Fig. 21 Restoration of gusset plate

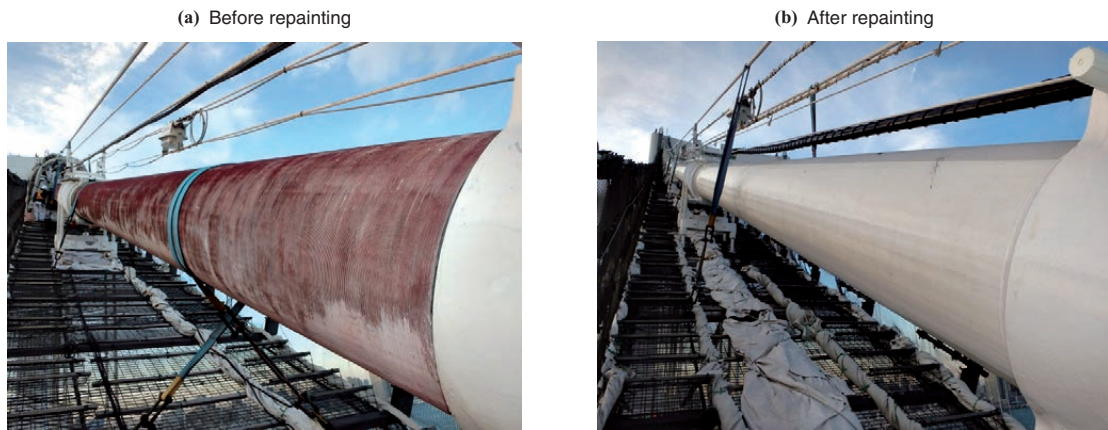
Rainbow Bridge (Tokyo Port Connecting Bridge) is a suspension bridge that was completed and brought into service in 1993. With about 20 years having elapsed since it went into service, the white top coats of the main cables deteriorated exposing a large portion of the reddish brown undercoats. Thus, repainting was required. It was then decided to repaint the cables and introduce a dry air injection system as corrosion prevention measures. With the area subject to these works divided into two zones (the Daiba Line and Shibaura zones), IIS undertook repainting in the Daiba Line zone (about half the entire work area). **Figure 22** shows situations before and after repainting. Repainting in the

Fig. 22 Before and after repainting

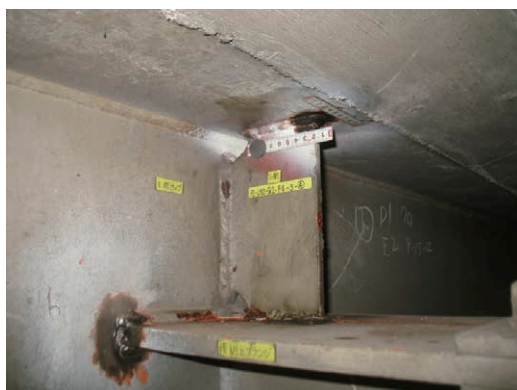
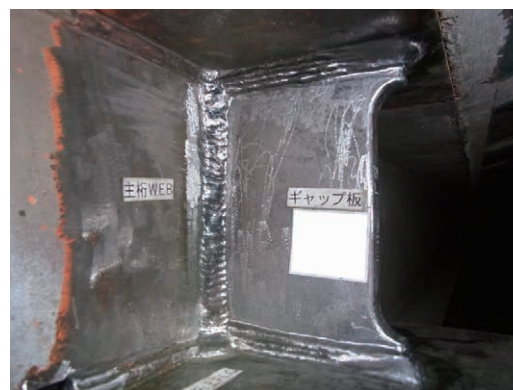
Cracking damage accounted for the largest portion of the cracks handled in this project and were present on web-gap plates. The method of repair was to replace damaged members with new ones, which involved welding. In order to ensure welding quality and the safety of existing structures, we conducted preliminary surveys and tests, including vibration checking for existing structures, management of the maximum welding heat input, and condition checking through welding tests. Advanced cracking damage was often found on a base material after removal of an existing member. In such cases, crack repair was performed in a reliable manner and then a new member was installed. **Figure 25** shows situations before and after web-gap plate replacement.

Fig. 25 Before and after replacement of web-gap plate

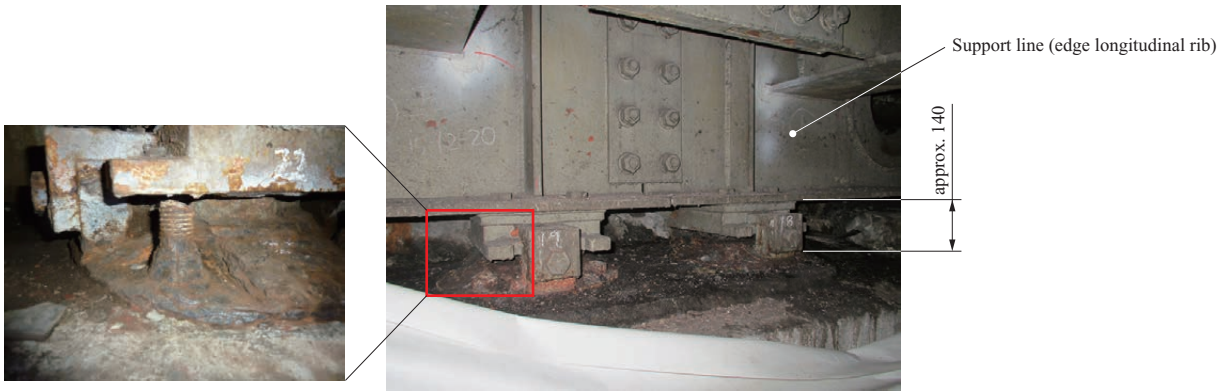
the primary objective of improving aseismic performance in many cases. In this project, however, support replacement was implemented to counter cracking damage or corrosion damage present in bridge support sections (six locations in total). The rest of this section will describe the support replacement work conducted at Iidabashi Exit (**Fig. 26**), which was the most difficult to execute among the support replacement works executed in this project.

Fig. 27 Before replacement of bridge support (unit : mm)

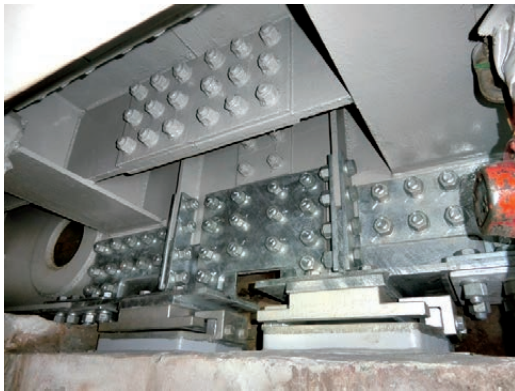
Fig. 28 After replacement of bridge support

was specified for rust prevention. For supports with more serious corrosion damage, two additional layers of solvent-free inorganic coating material (product name: Ceramax #1000AL) were applied to the surfaces subjected to hot dip galvanizing in order to improve their durability.

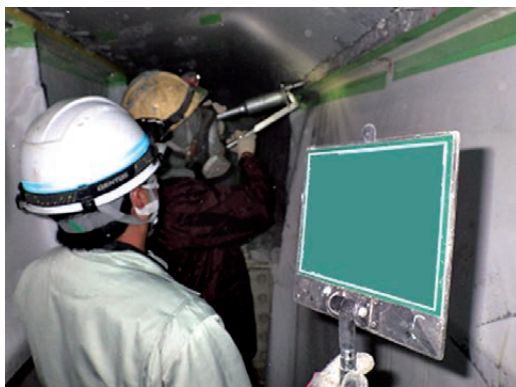
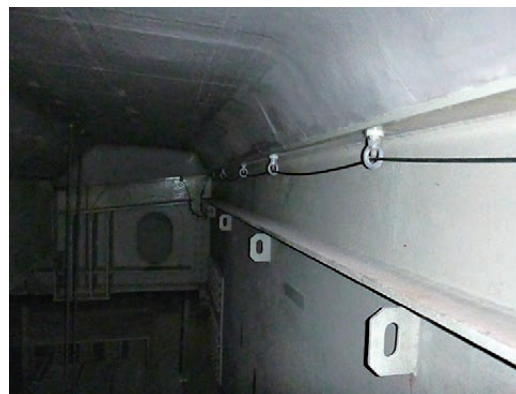
The slab anchor joining the steel superstructure and the concrete slab had fractured due to the fatigue damage, causing the formation of a gap between the steel and concrete boundary surfaces. Due to this gap, abnormal noise had been produced every time a vehicle passed. Although the slab anchor fracture seemed to be attributable to the deflection difference between the main girders and to repeating fluctuations in the intersection angle between flange and web resulting from the deflection of the concrete slab, it was difficult to come up with measures to reduce such deflection difference and deflection. In the end, we placed a metal anchor in the existing gap and injected epoxy resin into the gap in order to restrict displacement. **Figure 29** shows the situation of resin injection and the situation after repair.

Fig. 29 Resin injection and after repairs

Due to the limited work space, it was difficult to ascertain the injectability of resin, which was to be injected onto one side of an extremely narrow gap. For this reason, we conducted a preliminary welding test, determining work processes providing high injectability and reflecting them in

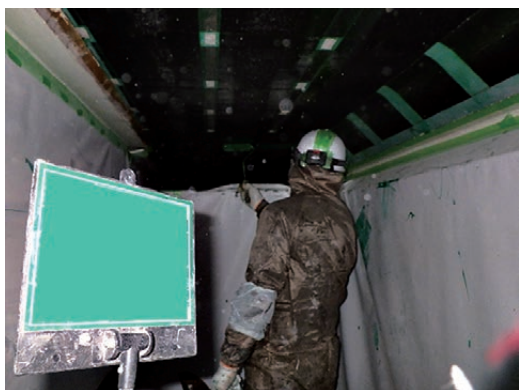
The concrete slab in the sections covered by the works executed in this project had multiple types of damage, including cracks and sectional deficits. Although such damage did not seem to immediately cause a critical defect, such as the falling of the concrete slab, carbon fiber reinforcements were implemented to suppress the advancement of deterioration from the perspective of preventive maintenance (Fig. 30).

Fig. 30 Work status for carbon fiber reinforcement
