DU-WÄRTSILÄ RT-flex Engine

April 2006

DIESEL UNITED, LTD.

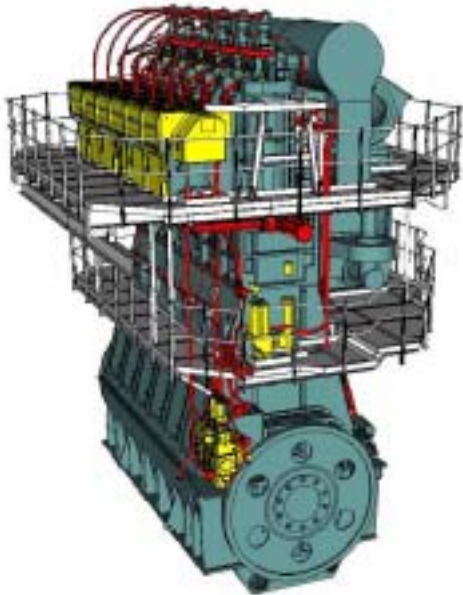
Characteristic of RT-flex Engine

Electronically controlled Fuel Injection
Exhaust Valve Drive
Starting Air
+
Common Rail Technology

Flexible and optimum engine tuning is available

- Improvement of fuel consumption
- Clean environment

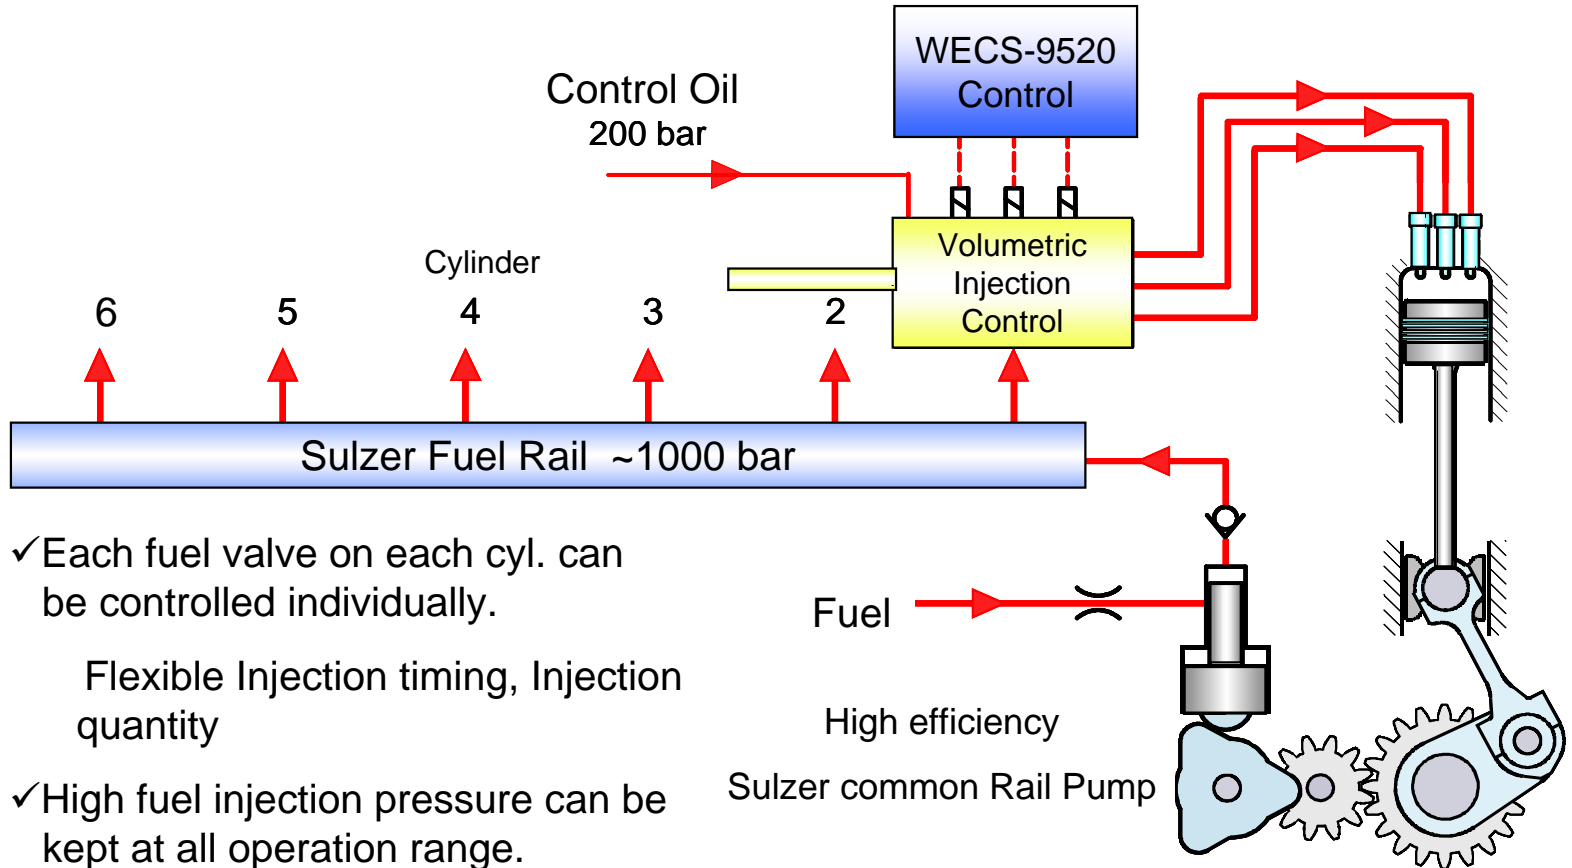
Fuel System

✓ Each fuel valve on each cyl. can be controlled individually.

Flexible Injection timing, Injection quantity

✓ High fuel injection pressure can be kept at all operation range.

High thermal efficiency

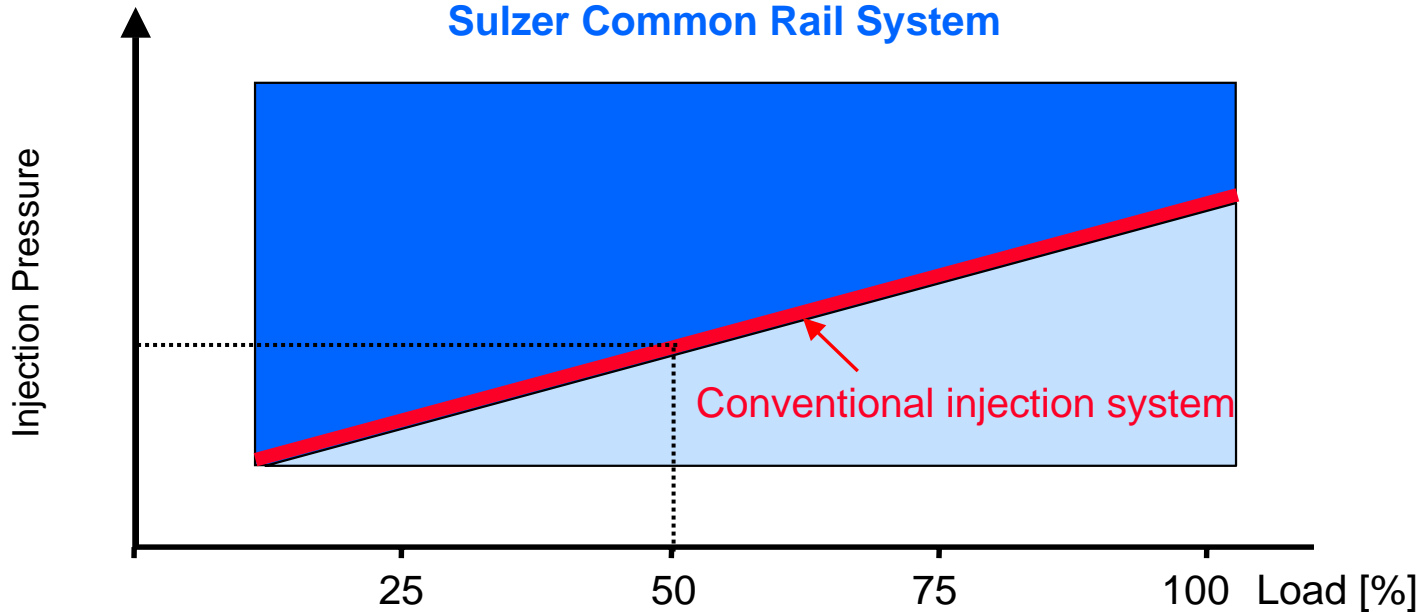
Fuel Injection Pressure of Common Rail System

Free selection of injection pressure

Low fuel consumption
Low Nox
Smokeless operation
Steady running at low load

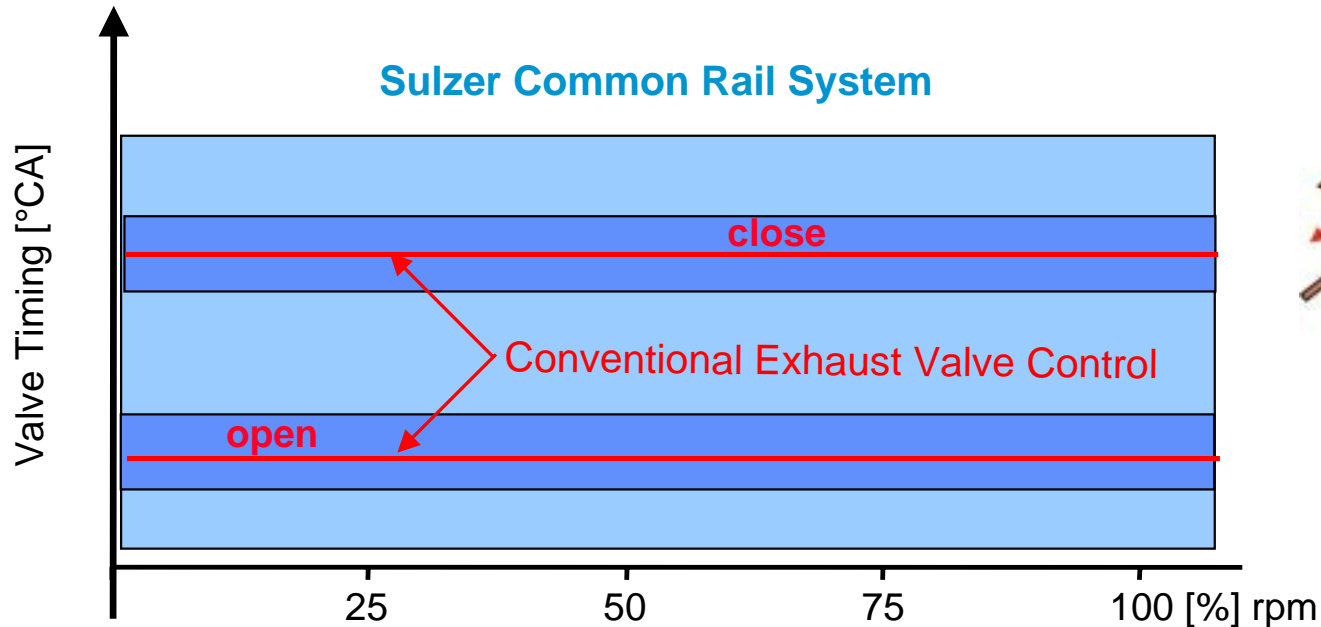
Exhaust Valve Timing of Sulzer Common Rail System

**Free selection of
exhaust valve timing**

**Low fuel consumption
Low Nox
Smokeless operation
Steady running at low load**

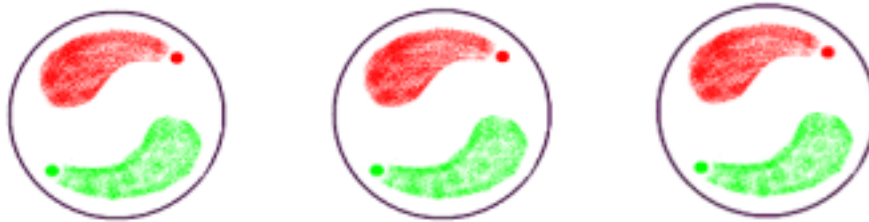
Standard injection pattern
2 nozzle operation

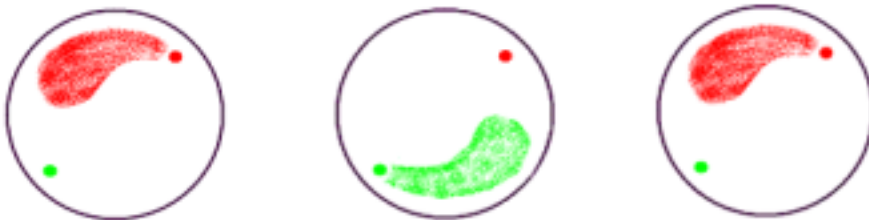
Low load :
1 nozzle operation

Smokeless operation down to 10-12% rpm R1
(13rpm for 6RT-flex50)

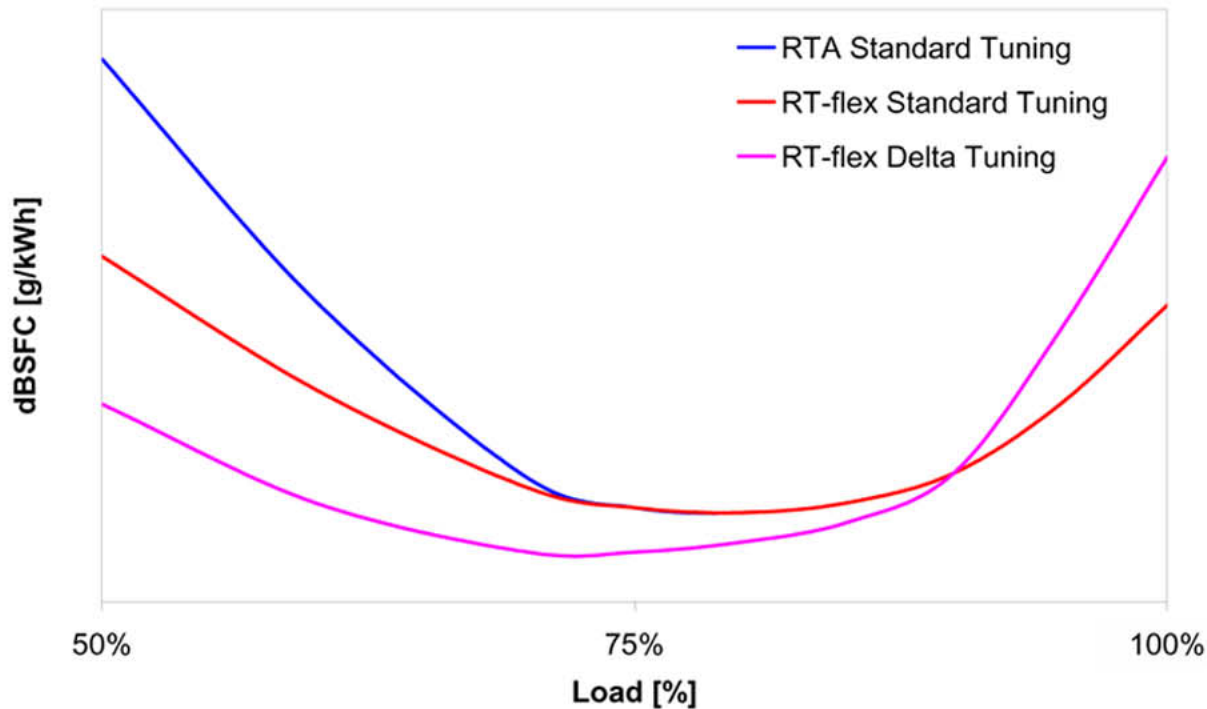
Difference of fuel consumption

High fuel injection pressure
Optimized exhaust valve timing

Reduced part-load fuel oil consumption

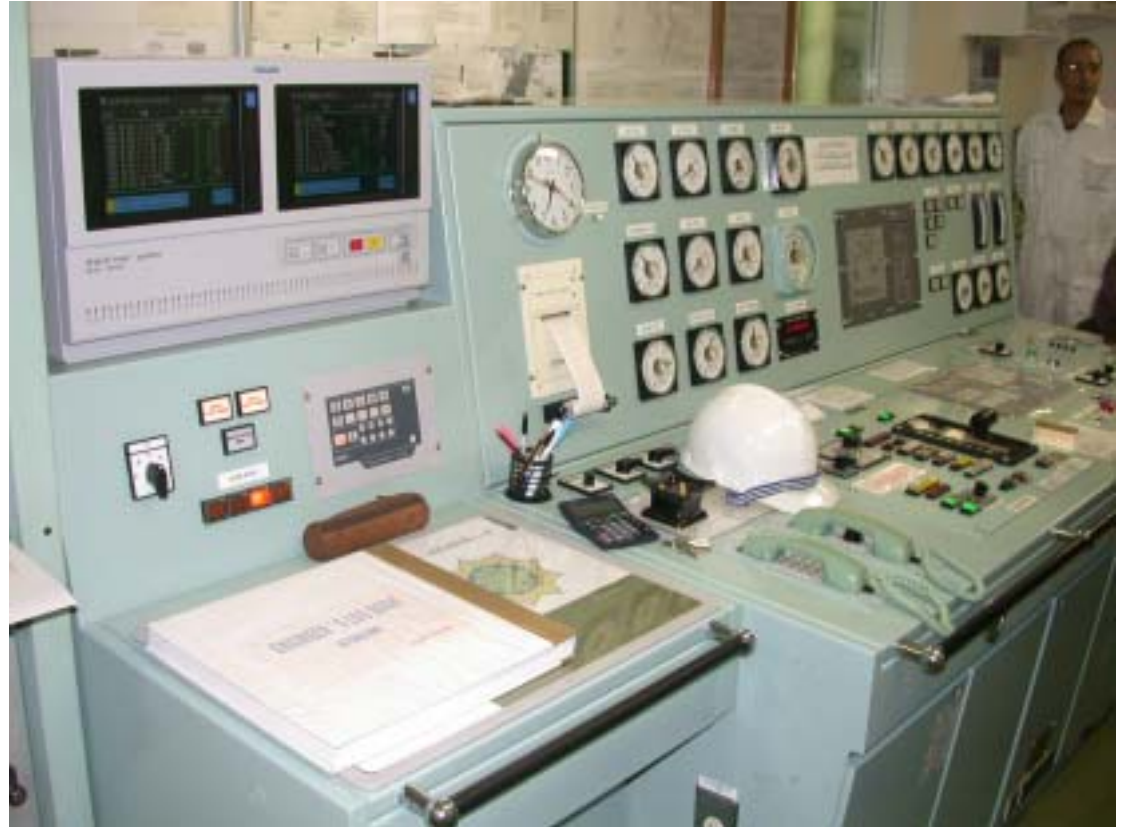
**Control console in
control room**

**Same arrangement
as console for
conventional engine**

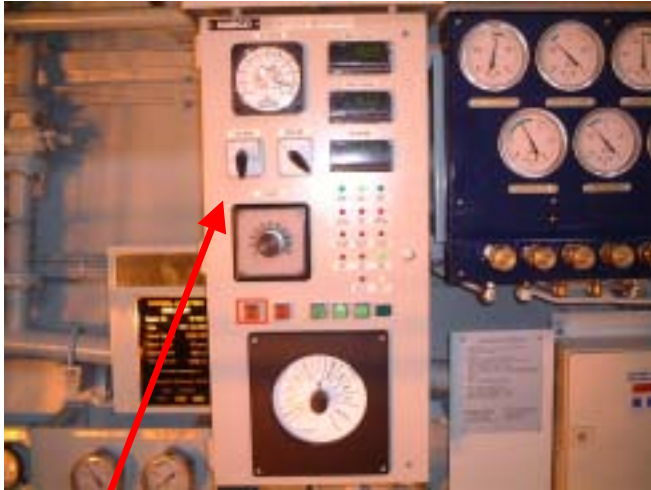
Engine side operation stand (RT-flex)

Control panel (without handle)

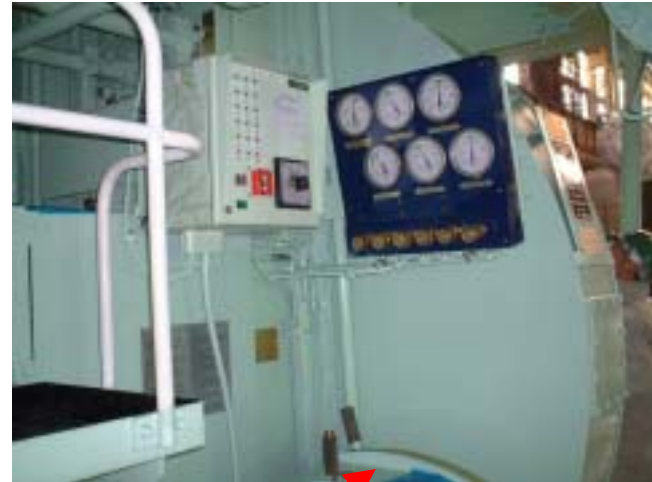
Engine side operation stand (RTA)

Operation by control handle

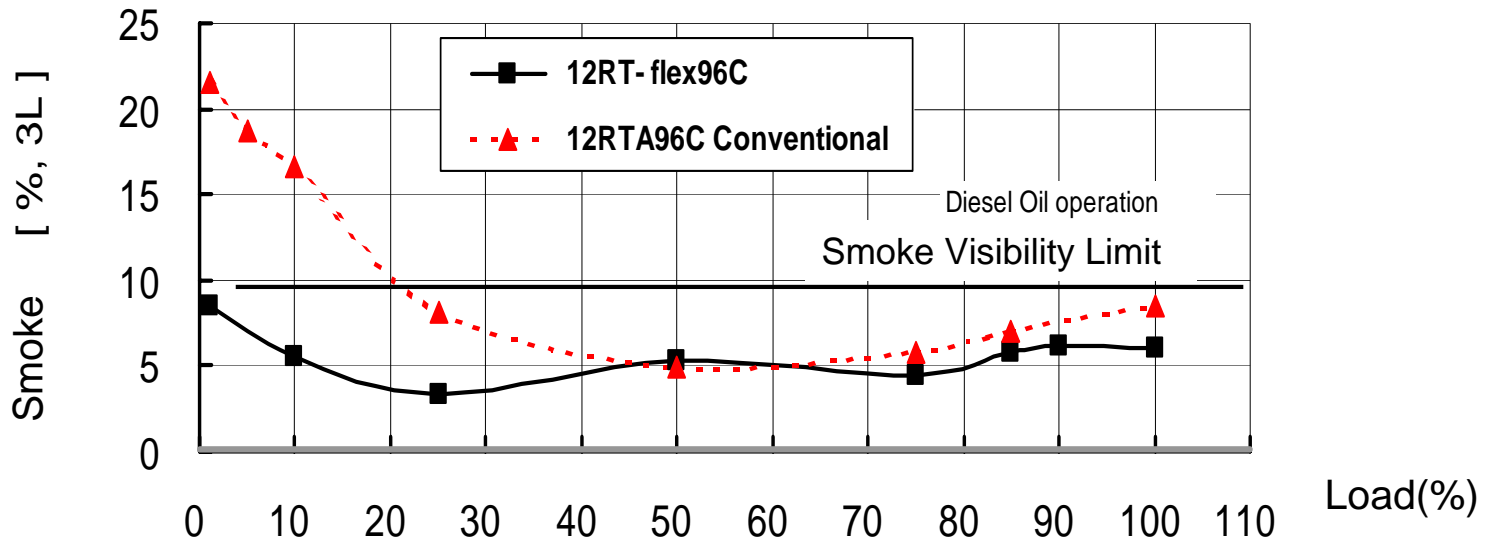
Smoke Measurement Result 12RT-flex96C

High injection pressure
Optimized exhaust valve timing
Sequential injection nozzle operation

Improvement of fuel injection
Smokeless operation at all operation range

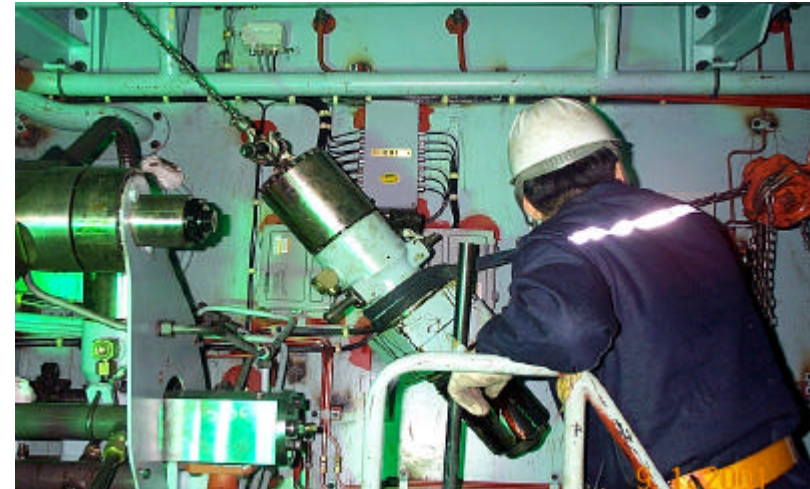
- Servo oil connecting pipes to collector block cracked

- ☞ Connecting pipes replaced by flexible hoses > **solved**

サーボオイル接続配管が振動で損傷 => 可撓継手に交換して解決

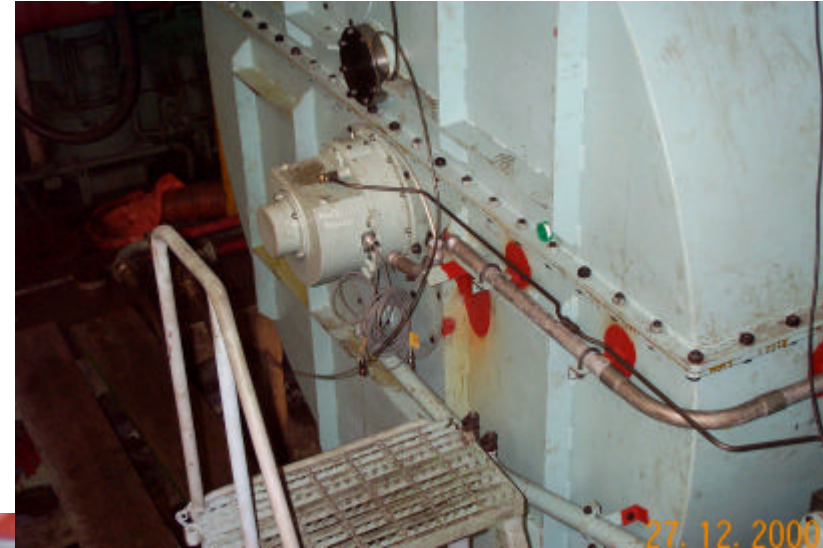
- Malfunction of some sensors
 - ☞ Sensors were defective or showed bad wiring
 - > solved
- Valve drive module failures
 - ☞ センサーが誤動作 = > 配線が悪く、センサーが故障
 - ☞ new print set-up for lower thermal stress of components
 - > solved
 - ☞ VDMが誤動作 = > 各製品の熱応力を下げるPCBの採用
- Regulating behaviour unsuitable for large swell and light ship
 - ☞ Software control loops modified for compatibility
 - > solved
 - ☞ 載荷条件により機関制御に不安定性が出た = > ソフトウェアの変更

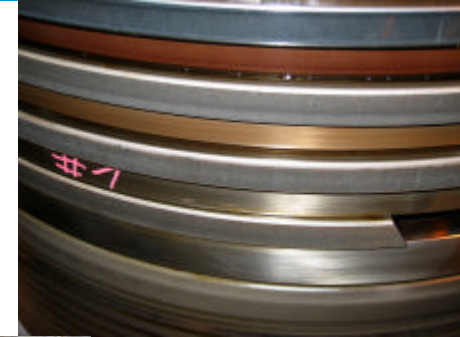
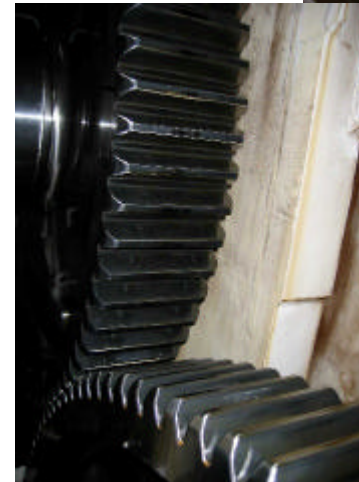
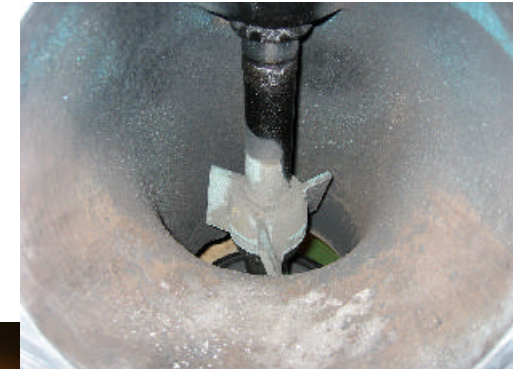
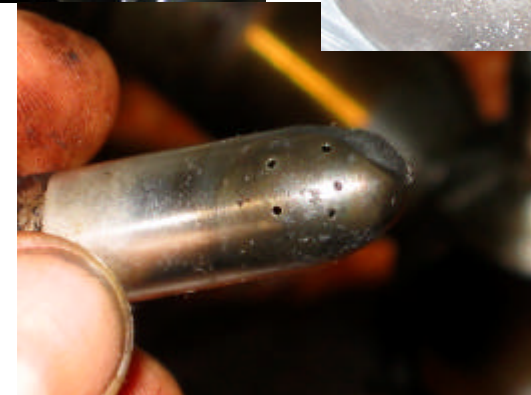
Conventional Parts

Very good results on liner wear
ライナ摩耗は良好

Very good result on piston ring wear
ピストンリング摩耗も良好

Very good load pattern on crankshaft gear wheel
クランク軸付歯車の歯当たり良好

Clean valve seat
排気弁座はきれいな状態を示す

Good injection nozzle shape
燃料弁ノズルチップも腐食や他の問題なく良好

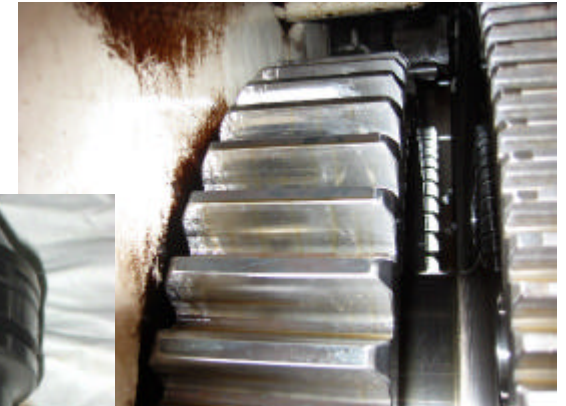
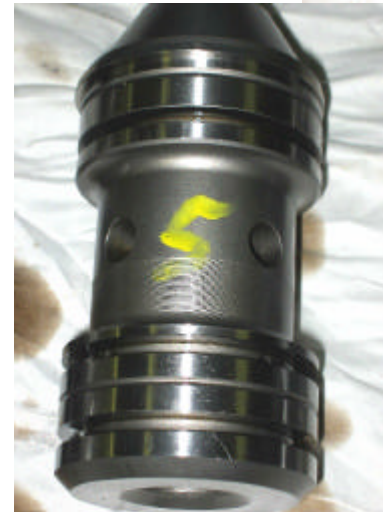
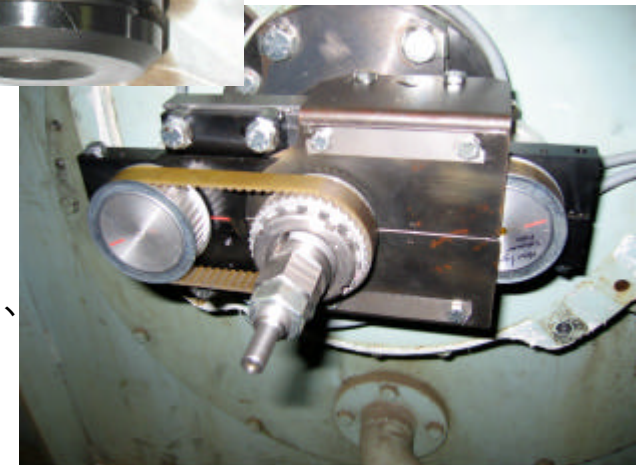
RT-flex Specific Parts

Very good load pattern on gear wheels of supply unit

No wear on fuel cams

No wear on hydraulic actuator for ExVa

No wear on crank angle sensor assembly

Electrically driven hydraulic pumps have been modified (couplings, vibs)

Emergency pressure regulating valve has been modified (tightness)

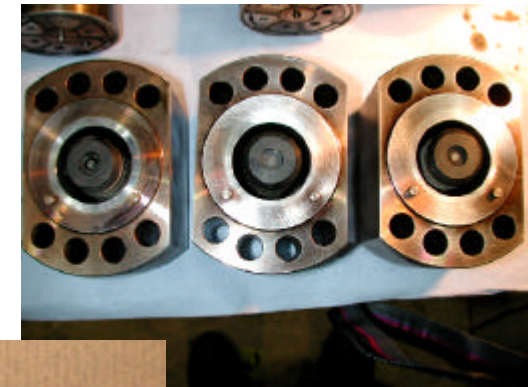
RT-flex Injection Control Unit

Shows absolutely same injection pattern as when tested new

No wear on sealing surface of injection

control valve

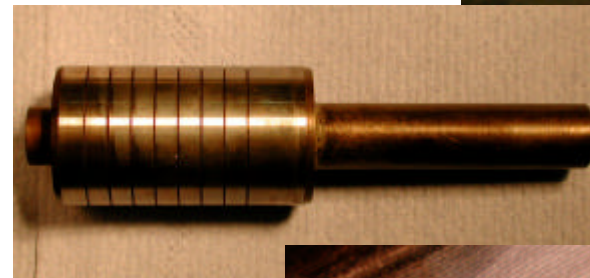
No wear on control oil piston

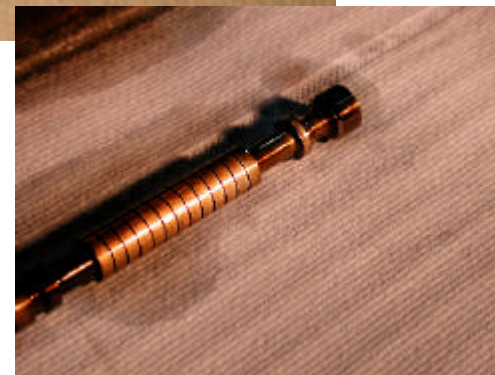
No wear on injection control valve slide

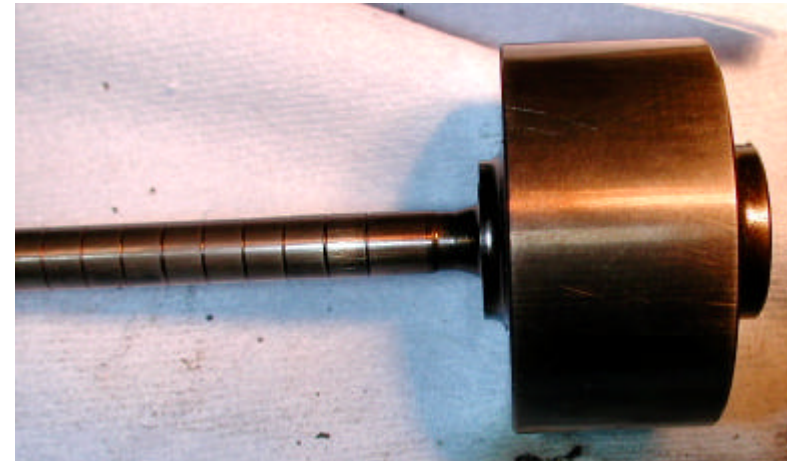
RT-flex Injection Control Unit

No wear on fuel quantity piston
燃料噴射量制御ピストンに摩耗なし

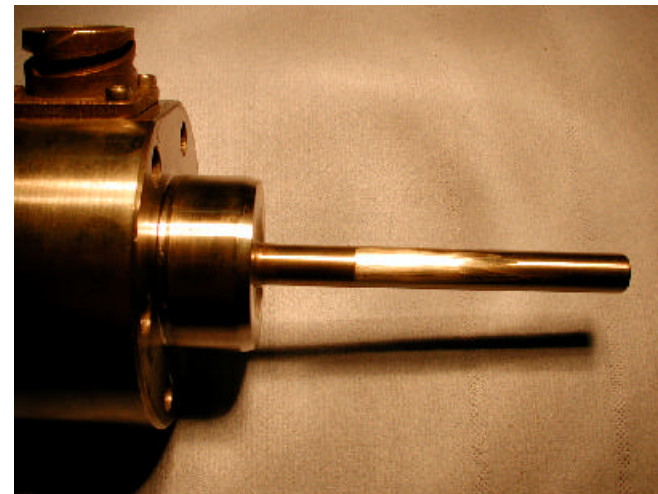
No change of wear on fuel quantity
sensor since beginning of operation
燃料噴射量検知センサーも連続使用中

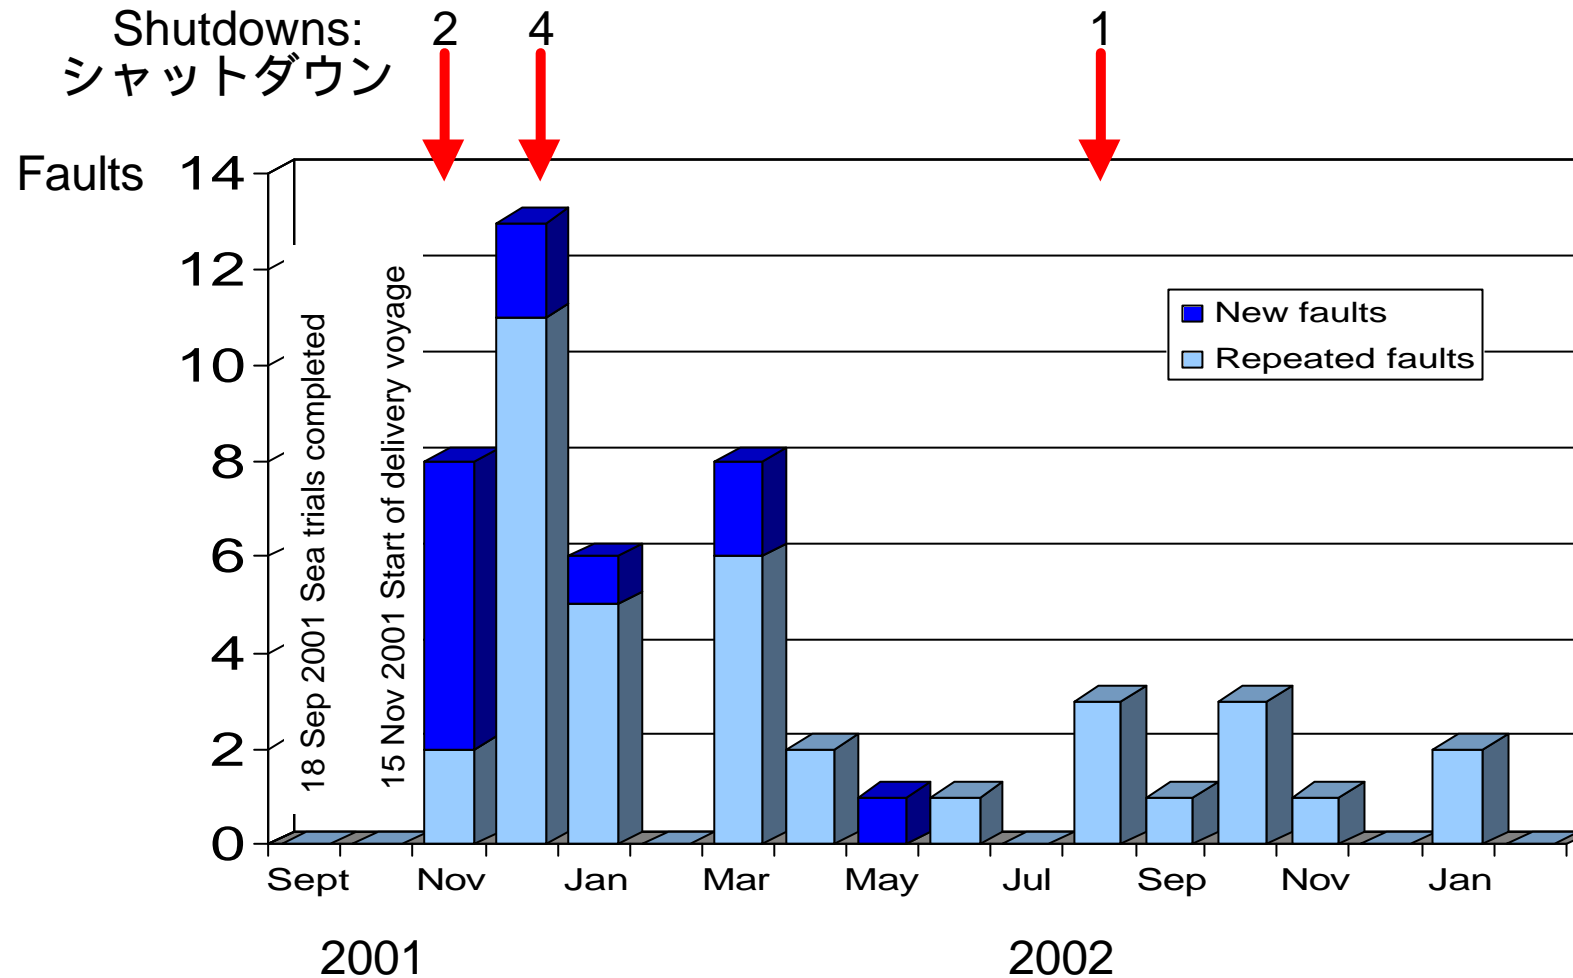
Fault History

Note that faults are only recorded from start of delivery voyage

Repeated faults are owing to time taken to develop final solutions

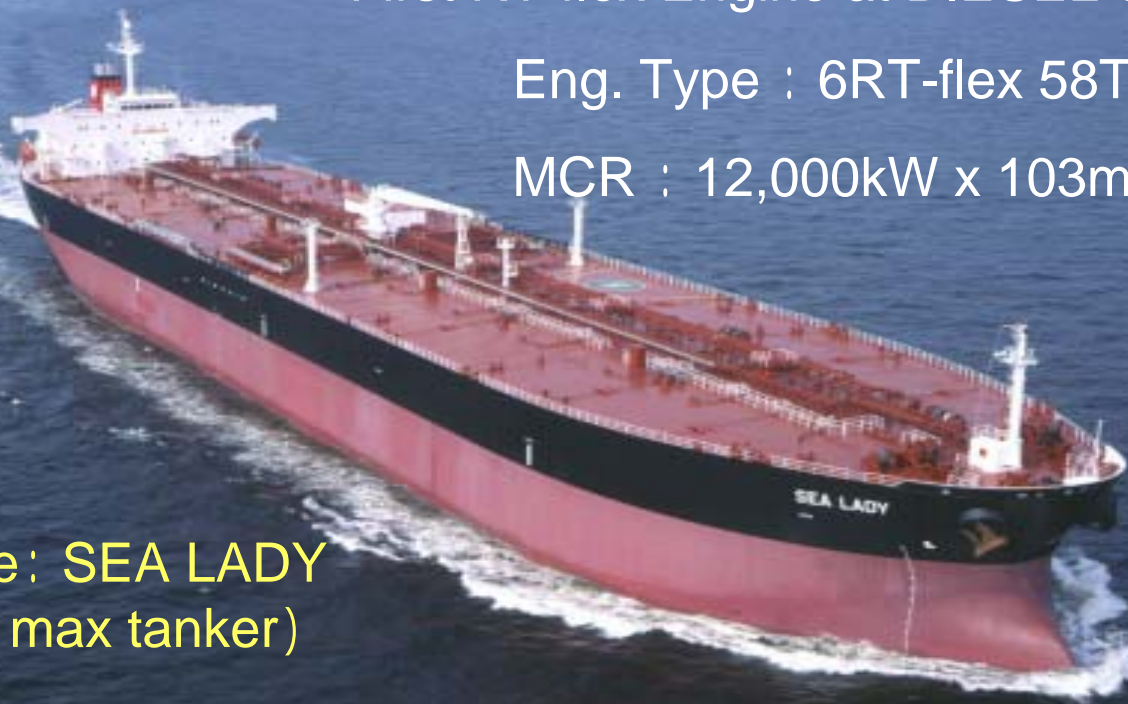
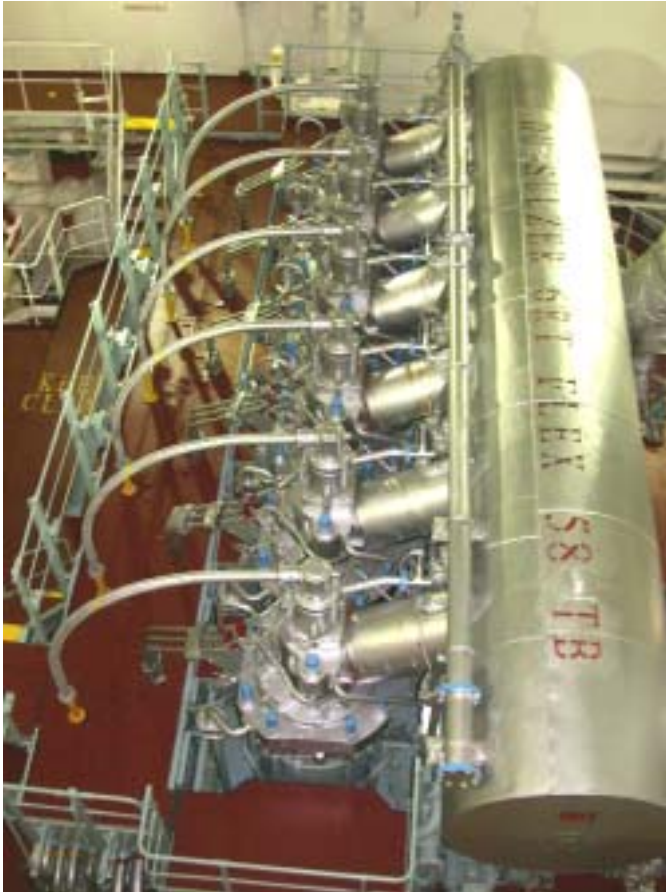
In Service : August 28 2003

Total running hour : 9,700 hrs
(September 2005)

- **Total run hour : 9,700 Hr
(September 2005)**
- **Cyl. Oil feed rate : 1.36 g/kW · hr
(85%Load)**
- **Some initial problems were solved.**
- **Operators quickly got acquainted to the flex system. Now the engine runs without problem.**

- Piston ring / Cylinder liner : Very good condition
- Crank shaft gear : Very good condition
- Sludge accumulation in piston under side on flex engine compared with conventional engines :
“Clear”, “Excellent” (Ship crew’s evaluation)
Extension of maintenance interval
