Demonstration Testing for 1 400°C Class CMC Shroud with JAXA F7 Turbofan Engine

Japan Aerospace Exploration Agency (JAXA) introduced F7-10 turbofan engine to demonstrate new aeroengine technologies developed in Japan by producing their usage environment with an actual engine. The engine is a high bypass ratio turbofan engine developed by Acquisition, Technology & Logistics Agency (ATLA) for P-1 maritime patrol aircraft. In the course of its development, IHI designed and manufactured it. Commissioned by New Energy and Industrial Technology Development Organization (NEDO), IHI developed a ceramic matrix composite (CMC) shroud which has 1 400°C class temperature capability and confirmed its soundness when mounted in the actual engine through a demonstration test conducted jointly with JAXA.

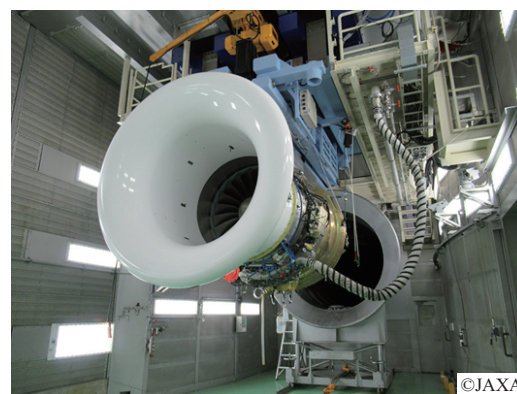
Fig. 1 JAXA F7 turbofan engine

In order to verify new technologies developed in Japan, the JAXA F7 turbofan engine shown in **Fig. 1** was introduced in 2019 for technical demonstration testing at the Japan Aerospace Exploration Agency (JAXA)⁽¹⁾. The F7 turbofan engine is a high-bypass ratio turbofan engine developed by the Acquisition, Technology & Logistics Agency (ATLA) for P-1 maritime patrol aircraft. IHI was in charge of designing and manufacturing the F7 turbofan engine. ATLA and IHI concluded a commercial transfer agreement for selling the JAXA F7 turbofan engine to JAXA, and it was introduced into JAXA in 2019. The JAXA F7 turbofan engine is expected to further promote the development of new technologies in Japan.

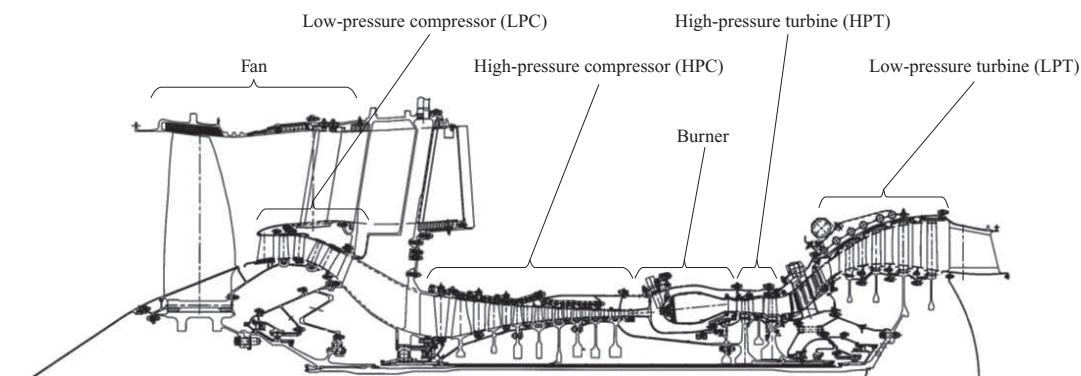
Fig. 2 Cross-sectional view of JAXA F7 turbofan engine⁽³⁾

On consignment from NEDO, IHI developed a shroud using 1400°C class CMC for demonstration testing. **Figure 2** shows a cross-sectional view of the entire engine. The demonstration testing described in this paper was intended for the first-stage shrouds of the high-pressure turbine. The turbine shrouds are located on the outer periphery of the turbine blades and have the function of forming a flow path surface of the mainstream gas. As shown in **Fig. 3**, the turbine shrouds are exposed to high-temperature, high-pressure gas, and receive thermal load, thermal distribution, differential pressure, vibrations, cyclically, and receive impact due to contact with the turbine blades (rubbing). Therefore, the turbine shrouds must be designed so that the required service life is satisfied in such an environment.

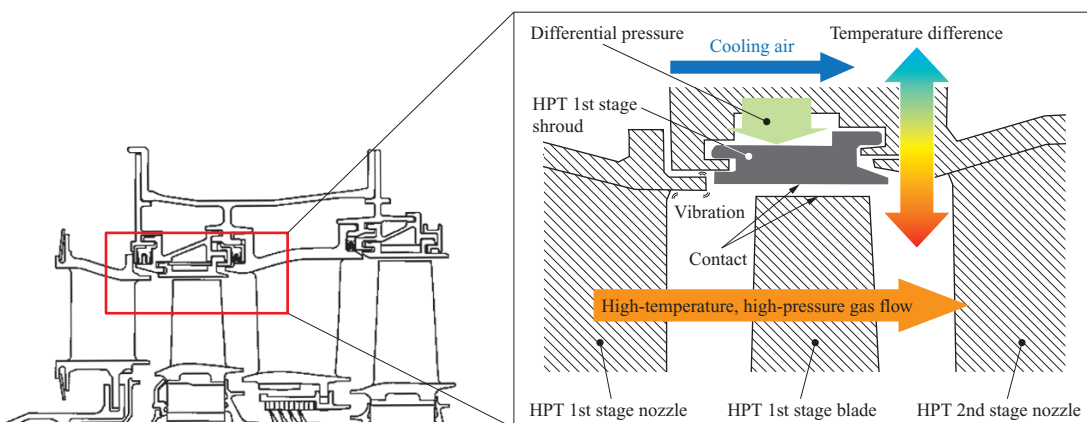
Fig. 3 Operating environment of high-pressure turbine shroud

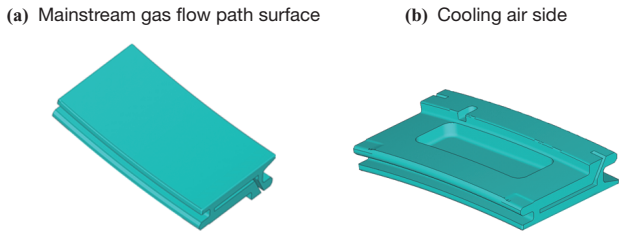
Fig. 4 CMC shroud geometry

Figure 4 shows the CMC shroud geometry designed so that the above requirement can be satisfied. **Figures 5 and 6** show the results of the thermal analysis and stress analysis, respectively. From the analysis results, we confirmed that the maximum design temperature is 1355°C, and the shroud has sufficient strength for the engine test conditions.

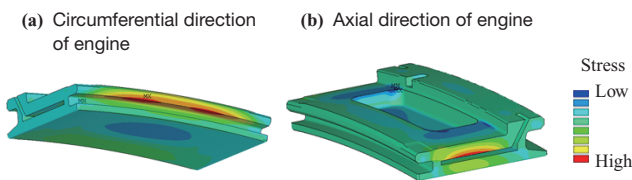
Fig. 6 Estimated stress distribution of CMC shroud

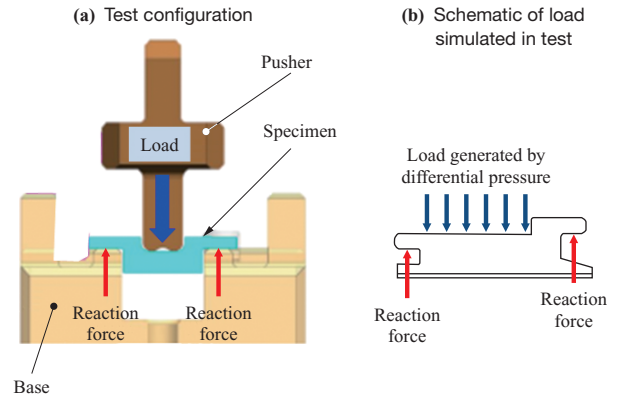
Fig. 7 Configuration of hook strength test

To verify the strength and soundness of the hook that supports the shroud, we conducted a strength test simulating the geometry, engine temperature, and applied load of the actual shroud hook. The test temperature was set to 920°C, which is the temperature of the hook in the engine test estimated by thermal analysis. **Figure 7** shows the configuration of the hook strength test. **Table 1** lists the test

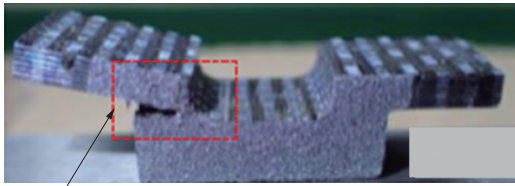
Fracture point

(Note) When fracture occurred at 13 443 cycles with a test load of 1 490 N

Fig. 8 Appearance of specimen No. 4 after the fatigue test

conditions and results. As a result of a static fracture test, we found that the fracture load of two specimens was approximately 2 500 N. In the fatigue test, two specimens did not fracture at 1 000 cycles with a test load of 810 N, which is equivalent to the load generated in the engine test, and two other specimens did not fracture at 1 000 cycles with a test load of 1 270 N, which is more than one and a half times as large as the load generated in the engine test. A load was applied in a stepwise manner to each specimen, and the fatigue test was continued until fracture. **Figure 8** shows the appearance of the fractured specimen No. 4 as representative examples. Specimen No. 4 fractured at 13 443 cycles with a test load of 1 490 N. These test results show that the shroud hook has sufficient strength.

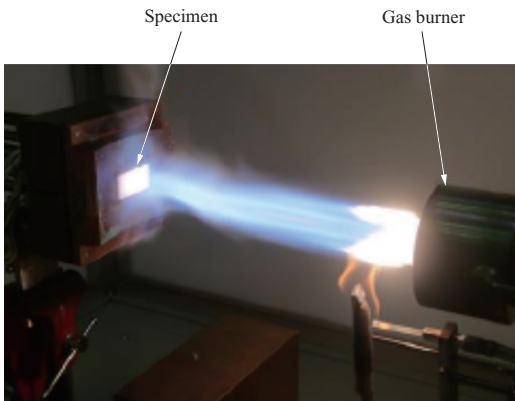
Fig. 10 Configuration of cyclic thermal test

To verify the soundness of the actual shroud against thermal cycling, the shroud was heated repeatedly with a gas burner. **Figure 9** shows the CMC shroud before the cyclic thermal test, and **Fig. 10** shows the test configuration. The CMC shroud was heated so that the maximum temperature on the mainstream gas flow path surface was 1 400°C and held for about two minutes to cool, repeatedly as a cycle. **Figure 11** shows the specimens after 1 000 cycles and after 2 000 cycles. After the test, no damage, except local EBC peeling, was observed on the specimens. The EBC peeled off only locally, which does not affect the functionality of the component even if it occurs in the engine test. We concluded that it would be no problem to proceed to the engine test.

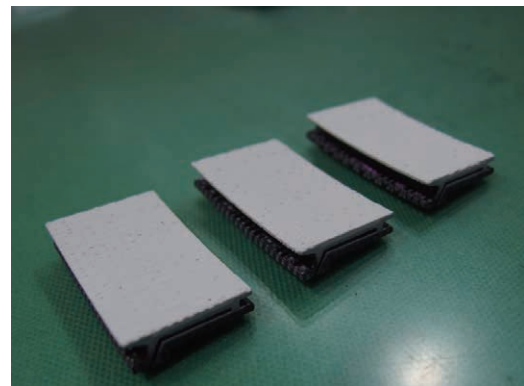
Fig. 12 CMC shrouds before the engine test

on the JAXA F7 turbofan engine. **Figure 12** shows the CMC shroud before the engine test. When the engine test was conducted, 8 out of 32 first-stage shrouds of the high-pressure turbine were replaced with the CMC shrouds. **Figure 13** shows the CMC shrouds assembled into a turbine case.

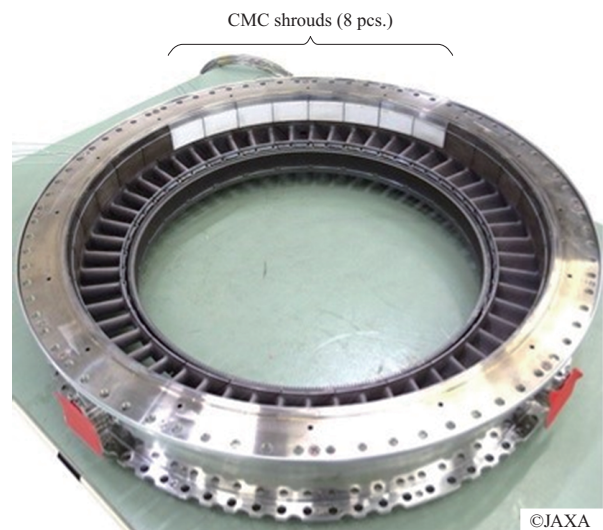
Fig. 13 CMC shrouds assembled into a turbine case

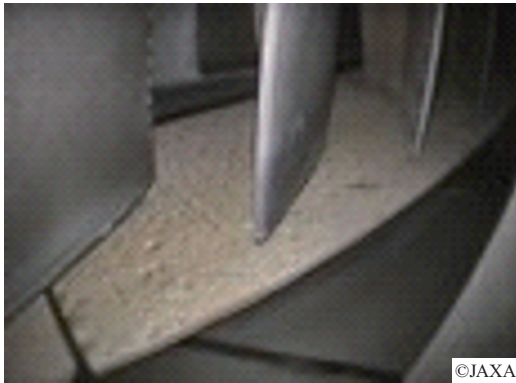
Fig. 14 CMC shroud observed with a borescope

During the operation test, the CMC shrouds and components around them were observed about every 10 hours with borescopes to check for any problems. **Figure 14** shows the condition of a CMC shroud observed with a borescope during operation.

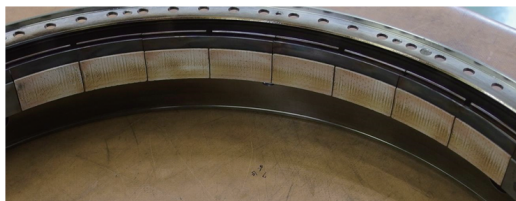
Fig. 15 CMC shrouds with turbine case after the engine test

After the engine test, the CMC shrouds were taken out and observed. **Figures 15 and 16** show the appearance of the CMC shrouds after the test. After the test, no shrouds or components around them fell off or seized, and the assembly condition remained unchanged from before the engine test. Major results of appearance observation are as follows:

- No damage, such as peeling, was observed on the EBC over the mainstream gas flow path surface.
- The entire surfaces of the shrouds were discolored to brownish red, and a component analysis found that Ca, Mg, Al, Fe, and other substances contained in the mainstream gas adhered.
- No remarkable wear was observed on the areas in contact with adjacent components, such as the hook.

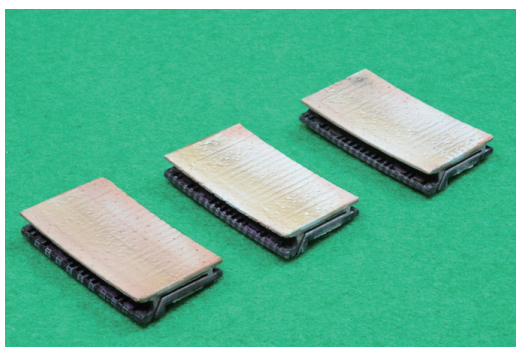
Fig. 16 CMC shrouds after the engine test

- No damage, such as burnout, chips, and cracks, was observed on the entire surfaces of the shrouds.

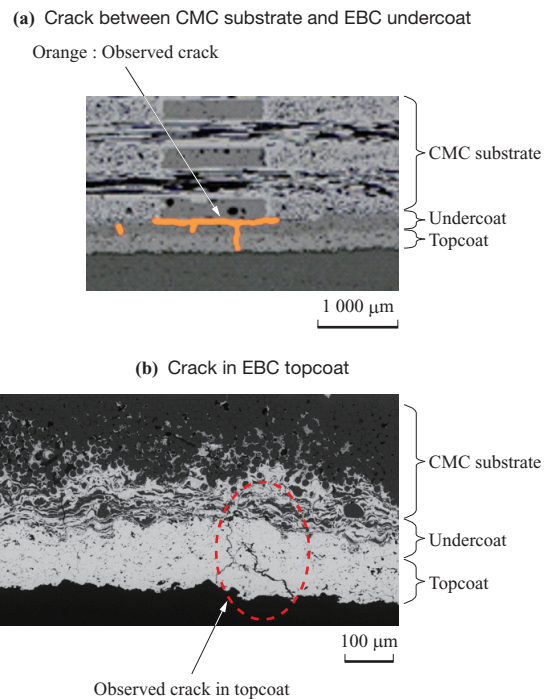
Fig. 17 Microscopic observation result of the cross section of the EBC area

After the engine test, the CMC shrouds were cut to check for changes in the internal condition. **Figure 17** shows the microscopic observation result of the cross section of the EBC area. As shown in **Fig. 17-(a)**, a crack was observed on the boundary between the CMC substrate and EBC undercoat. Also, as shown in **Fig. 17-(b)**, a crack was observed in the EBC topcoat. These cracks were determined to have occurred during the engine test. We also observed the microstructure of the inside of the CMC substrate through a microscope. **Figure 18** shows the microscopic observation result of the cross section around the shroud surface. No significant changes were observed in the internal microstructure, except some areas near the shroud surface. In some areas around the shroud surface, the BN coating oxidized in the fabric interface.

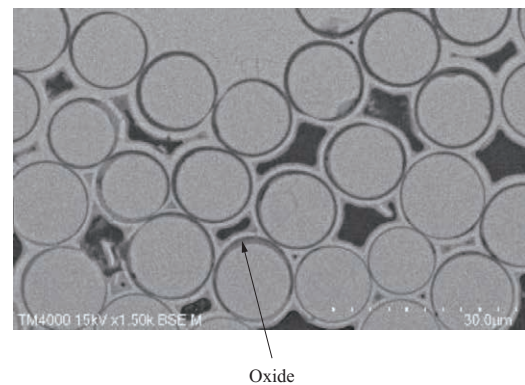
Fig. 18 Microscopic observation result of the cross section around the surface
