# System for Diagnosing Concrete Deterioration with Spectroscopic Analysis

IHI Group has already reported research findings on the spectroscopic diagnosis system.<sup>(2)-(5)</sup> This paper describes the application of the spectroscopic diagnosis system to three in-service bridges in different surrounding environments and of different structures in order to verify the precision of non-destructive inspection by means of spectroscopic analysis versus the precision of destructive inspection.

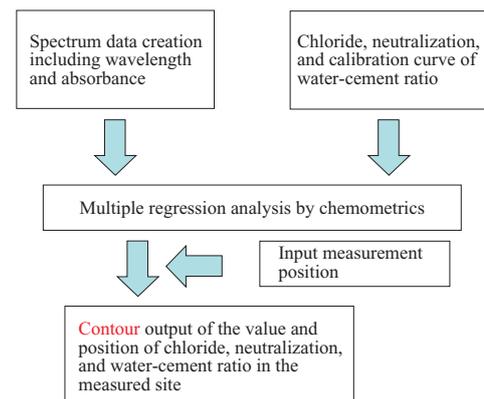
Fig. 1 System output flowchart

Spectroscopic analysis is a multiple regression analysis technique with chemometrics as illustrated in the flowchart in Fig. 1. This system is already established as a non-

destructive inspection technology extensively used for measuring the sugar content of fruits. The system described in this paper applies the same technology so that a contour map of saline concentration is displayed once the measurement position is input. In principle, it is also possible to diagnose chemical neutrality by employing a calibration curve of calcium carbonate concentration, etc. Furthermore, diagnosis can be performed with alkaline aggregate reaction and other chemical deteriorations once correlations can be found between non-destructive and destructive inspections.

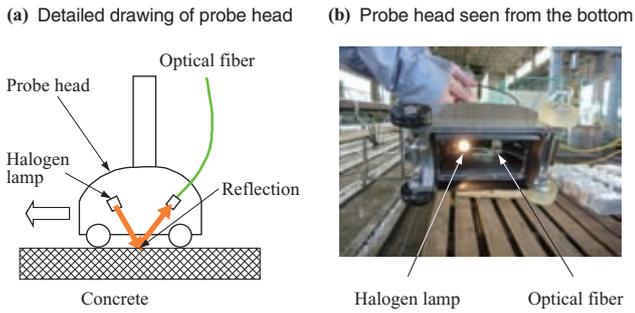
The spectroscopic analysis system performs measurements by scanning the concrete surface with an approximately 150 × 100 mm device called a probe head, as illustrated in Fig. 2. Measurement is made in a closed system without ambient light such as sunlight while the surface of the concrete is illuminated by a halogen lamp, the reflected light of which is collected into an optical fiber.

Fig. 2 Outline of probe head

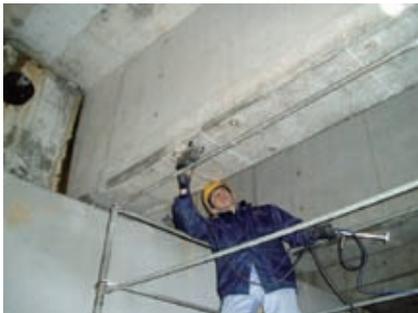
Figure 4 shows the actual measurement situation (-(a)) and the data output method (-(b)) according to the system.

(a) Actual measurement

The example here shows the measurement of the bottom surface of the Pre-stressed Concrete (PC) bridge beam. The beam has a width of 500 mm, which can be measured in five lines because of the width of the probe head. Data on the wavelength and intensity of light received (Fig. 4-(c)) can be obtained longitudinally every 50 mm. Chloride ion concentration can be output for the measured area.

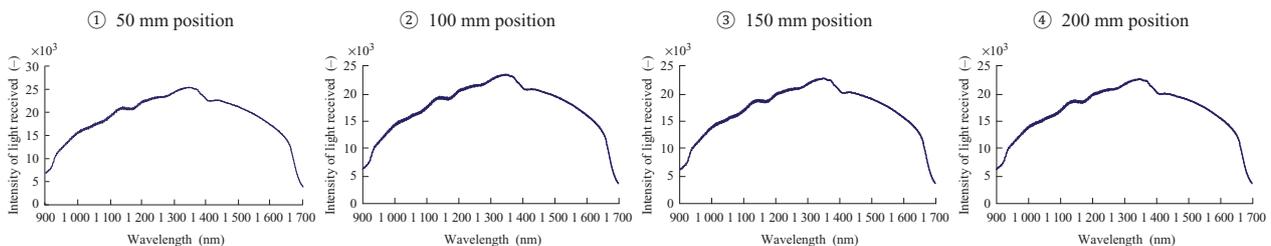
(c) Output of wavelength and intensity of light received for each spot (50 mm pitch)

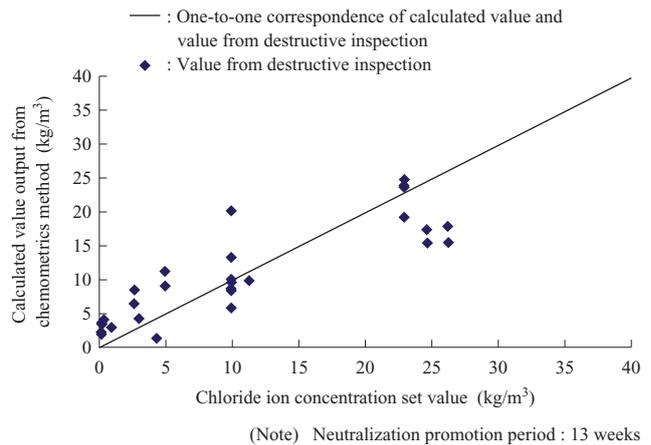
The Chemometrics method offers a solution to this problem. A calibration curve with clear correlation as shown in Fig. 3 can be obtained by selecting multiple peaks corresponding to the chloride ion concentration and calcium hydroxide. The results can be used for correctly measuring the surface chloride ion concentration without being influenced by neutralization.

Fig. 3 Plotted calibration curve

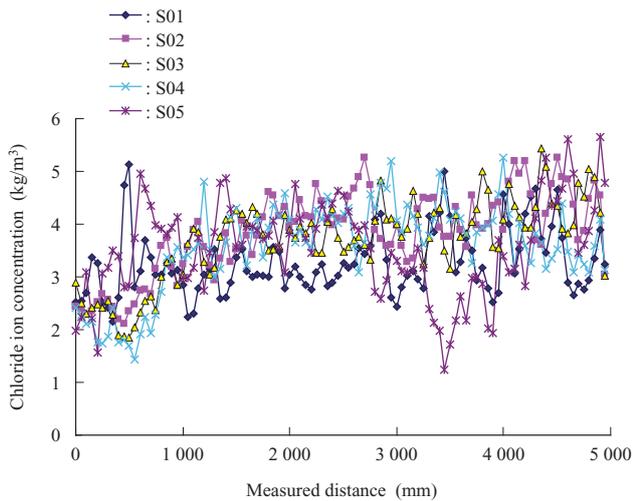
Since the probe head used in this system has a built-in encoder which can output the scanned distance, a graph of chloride ion concentration over the distance can be produced as shown in Fig. 5. By merging this information with CAD-generated data of the measured area, a contour map as shown in Fig. 6 can be produced. As a result, spots with higher chloride ion concentration in the measured site become visible at a glance.

Fig. 5 Profile of chloride ion concentration versus measured distance

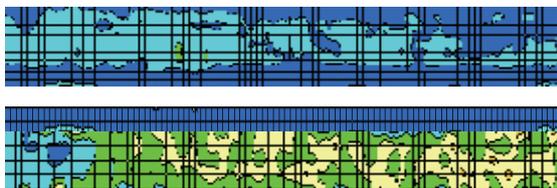
Fig. 6 Example of contour map output

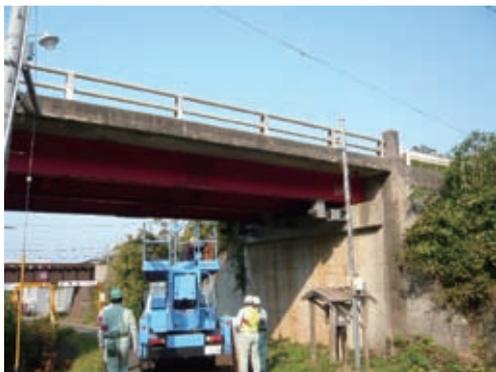
Figure 7 shows the appearance of measured bridge, bridge A. The bridge faces the Sea of Japan, 250 m from the coast. The bridge is 19.9 m long and 8.3 m wide and has a single-span steel beam structure with RC slabs.

The bridge is exposed to seasonal winds in the winter. It has been in service for 38 years. The surface of the slabs is impregnated with silane-siloxane aqueous emulsion to protect against salt damage. As to deterioration of

Fig. 7 Appearance of bridge A

the concrete surface, some cracks and some spalling in concrete sections, caused by salt from the sea and snow melting agent are observed in the overhang parts. Slabs in the section between beams were sound without noticeable deterioration.

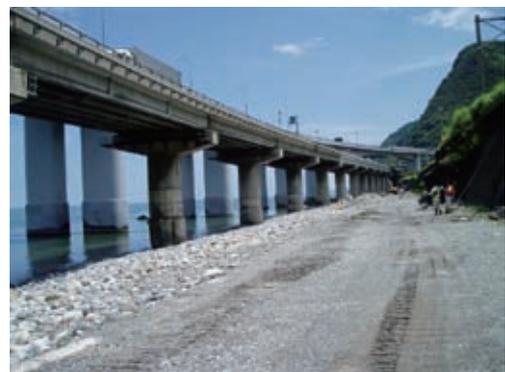
Figure 8 shows the appearance of a measured bridge, bridge B. This bridge also faces the Sea of Japan and stands on the coast. The bridge is 991.6 m long and 11.25 m wide and has a simple post-tensioned T-beam structure with 31 spans. The measured area is on a span on the land section. It has been in service for 37 years. In the parts where concrete is exposed, cracks and deterioration of repaired sections due to salt damage were observed.

Fig. 8 Appearance of bridge B

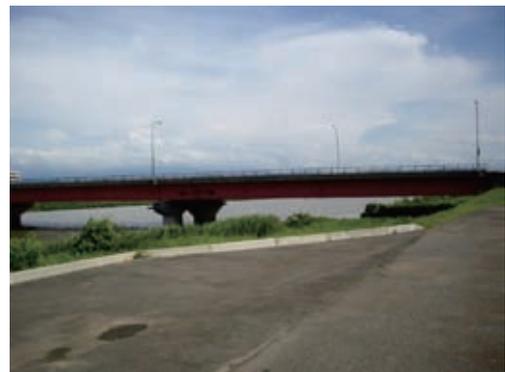
Figure 9 shows the appearance of a measured bridge, bridge C. This bridge stands 1 km inland from the mouth of the river and therefore is not affected by salt from the sea. Nevertheless, a large amount of snow melting agent is sprinkled on it in the winter. The bridge is 264.6 m long and 26 m wide and has a 2-span box beam and 3-span continuous steel beam structure. It has been in service for 28 years. No conspicuous deterioration is observed except for cracks in some places which were most likely caused by drying shrinkage.

Fig. 9 Appearance of bridge C

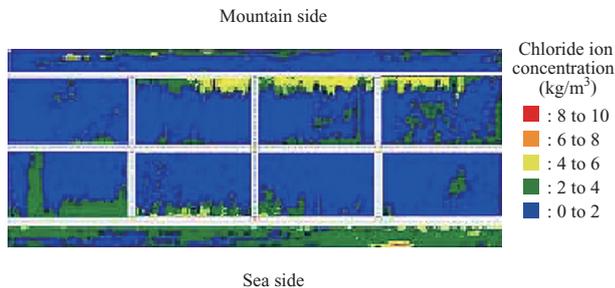
Figure 10 shows the chloride ion concentration measurement results of bridge A. The overhang and beam on the side facing the sea show high chloride ion concentration. This finding indicates the influence of salt from the sea that adhered to the bottom of the slabs. For this reason, spalling of concrete sections due to corrosion of reinforcing bars was observed in overhang segments with small covered areas. As to the slabs, because they are largely covered, no impact from reinforcement corrosion was observed.

Fig. 10 Chloride ion contour map for bridge A

In addition, the chloride ion concentration on the concrete surface measured by spectroscopic analysis was compared with the estimates from the sampling method in order to verify the accuracy. Comparison was made in three areas which resulted in the negligible difference of  $0.6 \text{ kg/m}^3$ . Thus, it was confirmed that the value obtained from the spectroscopic analysis can be directly regarded as the actual chloride ion concentration on the concrete surface.

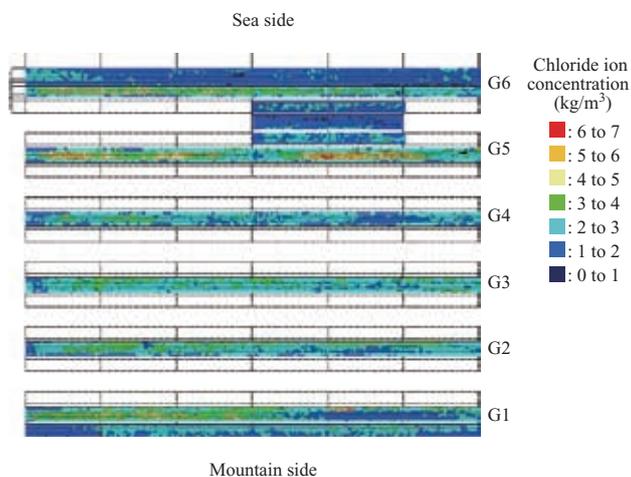
Figure 11 shows the chloride ion concentration measurement results of bridge B. It was initially expected

Fig. 11 Chloride ion contour map for bridge B

that the side of beam G6, which faces the sea, would demonstrate the highest chloride ion concentration. In actuality, it was the bottom of the beam that was detected as having the highest concentration. Moreover, it was not beam G6, which is the closest to the sea, but beam G5, which is one span inland, that had the highest chloride ion concentration. This is believed to be the result of the cleansing effect of rain water that falls on the beam on the outside. The inner side of the beam and slab had a lower concentration compared to the bottom of the beam. This finding revealed that the structure of bridge B experiences more adhesion of salt from the sea on the bottom of the beams, but not between the beams.

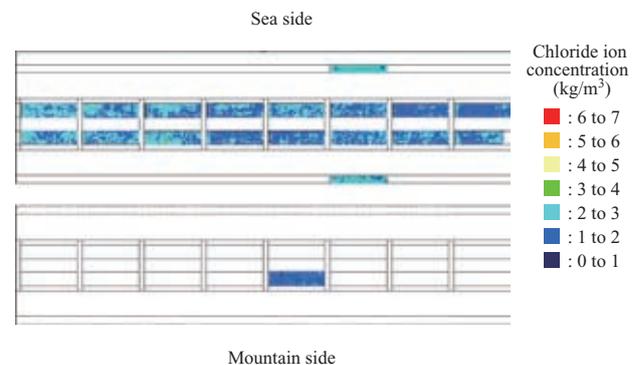
Figure 12 shows the chloride ion concentration measurement results of bridge C. The bridge is not affected by salt from the sea, as it is located inland. The chloride ion concentration on the surface, therefore, is below  $3 \text{ kg/m}^3$  almost everywhere without any particular sites with significantly high concentration. The highest concentration was observed in a concrete joint with a maximum measurement of  $4.8 \text{ kg/m}^3$ . According to this finding, this bridge requires more consideration for the effect of local application of snow melting agent because of the inland location, rather than the effect of salt from the sea.

Fig. 12 Chloride ion contour map for bridge C

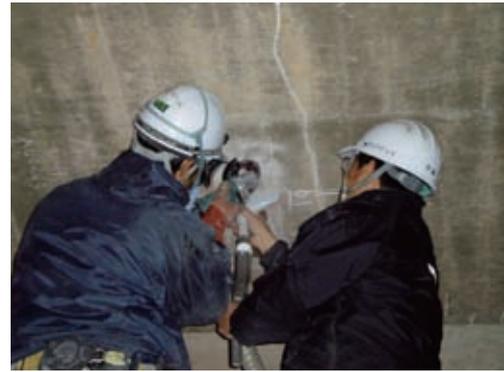
**Figure 13** shows the estimation results of chloride ion concentration inside the concrete of bridge B **(-a)** and bridge C **(-b)**). As shown in **Fig. 14**, the value corresponding to the surface is obtained by analyzing the powder scraped off from the surface with a grinder and collected by a cyclone vacuum. A value corresponding to the interior was obtained by analyzing sample concrete that was sliced and crushed. The resultant values were used to calculate a diffusion coefficient by curve fitting with Equation (1). The curve according to the spectroscopic analysis was drawn by assigning the measured value to  $C_0$  and applying the diffusion coefficient derived from the analysis of the surface powder and sample. The value predicted by the spectroscopic analysis proved larger than the analytical value obtained from the actual sample.

**Fig. 14** Sampling powder from concrete surface

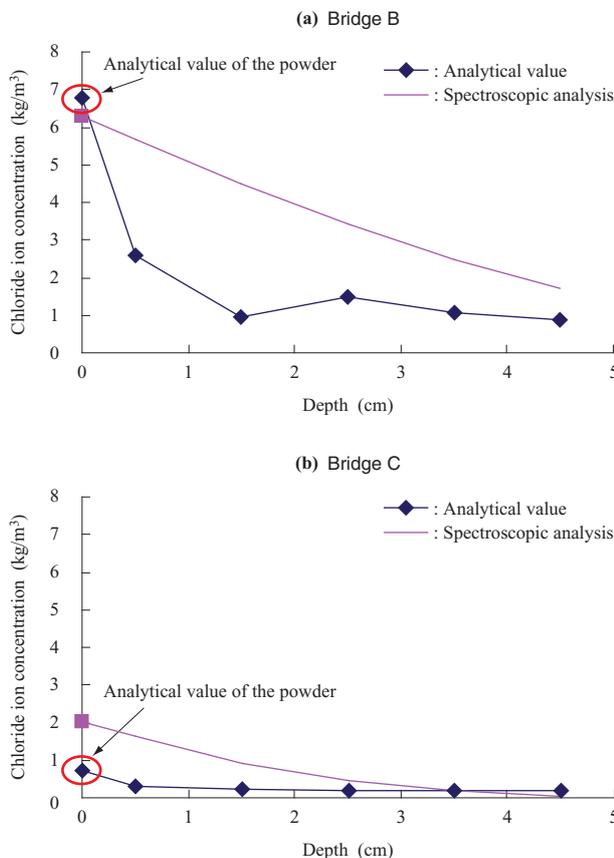
**Fig. 13** Estimated chloride ion concentration versus depth of concrete

According to the above method, it is possible to estimate the diffusion status inside concrete based on the chloride ion concentration on the surface of concrete measured by spectroscopic analysis. Determination of reinforcement corrosion is made by comparing the chloride ion concentration at the depth where reinforcing bars are situated with the defined value (normally  $1.2 \text{ kg}/\text{m}^3$ ).
