# APM System Extension and Signaling System Replacement at Hong Kong International Airport

IHI and Niigata Transys Co., Ltd. have successfully completed an APM line-extension project at Hong Kong International Airport. In addition to the 1 400 meter APM line extension and new vehicles, the signaling system was completely replaced with a new system in this project. One of the challenges was to minimize the project's impact to the daily operation of the current APM service. Another aspect of this project was that the new system required integration for four types of trains including, these supplied by another manufactures. Through this project, we had a chance to learn a lot and to build up our experience, particularly regarding the best practical methods when building APM line extensions and providing the latest technology to existing facilities.

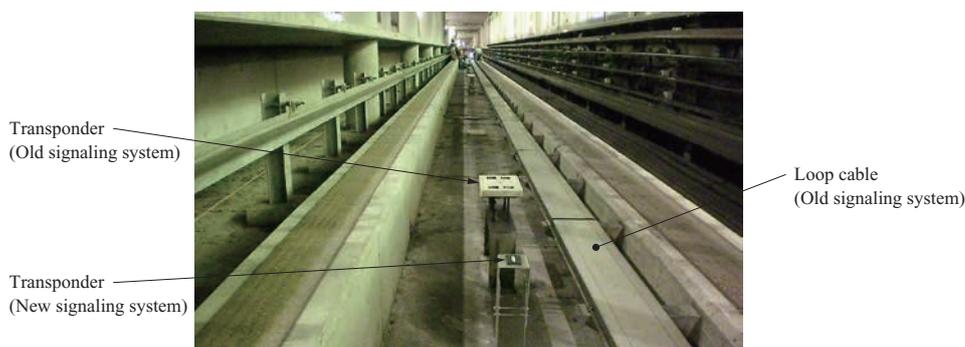
transmitter receivers for the old signaling system and two types of transmitter receivers for the new signaling system were installed. Since no metal was allowed to be used within a certain distance of each transmitter receiver to prevent misdetection, and the old vehicles had already been loaded with underfloor equipment, locations that accommodated the transmitter receivers of the new signaling system were limited. For this reason, locations of the new signaling system's wayside equipment and transponders installed in guideway were dependent on the layout of the underfloor equipment in the vehicles. **Figure 2** shows both signaling systems' wayside equipment and transponders installed in the guideway.

**Fig. 2** Trackside equipment for new and old signaling systems

In the period of replacement works, some of the devices of the new and old signaling systems must be located along each track while avoiding physical interference between them. The old signaling system used a tightly coupled inductive radio system, i.e. transmitter receivers between the wayside and the on-board equipment were located close to each other. The wayside signal transmission loop cables were installed in the guideway over the entire lengths of the tracks. In addition, transponders for position reference during deceleration and stopping at stations were also installed in the guideway.

For the new signaling system, we adopted a state-of-the-art Communication-Based Train Control (CBTC) system provided by Thales. This system performs data exchange between the wayside equipment and the on-board equipment via a 2.4 GHz wireless LAN. Wayside transmitter receivers (access points) were installed on tunnel walls at intervals of 100 to 200 m. As a result, the number of devices installed in the wayside was reduced, so that the wayside equipment of both the old and new signaling systems could be laid out together.

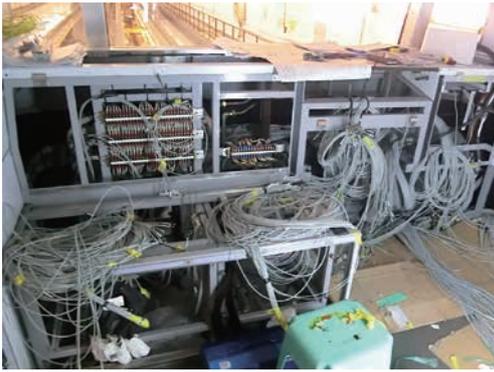
**Fig. 3** Vehicle interior during modification work

During the vehicle modification work, we had to deal with the lack of space for installing devices and cables. Due to their intrinsically compact design, the vehicles lacked empty spaces. Also we had to leave the old signaling system as it was. Therefore when installing new on-board controllers on the old vehicles, we removed some of the seats and then installed their housings. In order to install additional cables that could not be installed in the existing underfloor cable duct, we installed additional cable duct in the ceilings. Because of these cables, terminal blocks also had to be added, and they were located taking ease of future maintenance into account to the maximum extent possible.

**Figure 3** provides a photograph of the vehicle modification

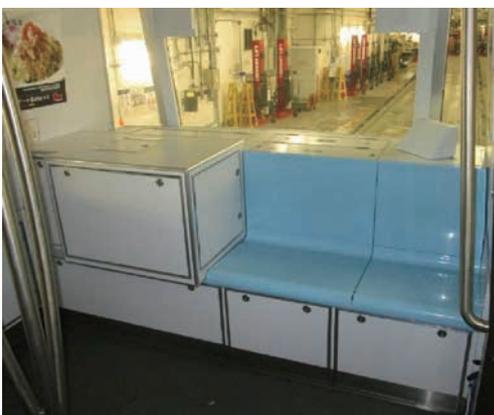
With the awareness of the risk that aged cables and connectors of the old vehicles would pose problems such as broken conductive wires and short-circuits, we took extra care (avoiding modification of the existing cables to the maximum extent possible, etc.) during the modification of the old vehicles to prevent the occurrence of problems. **Figure 4** shows a vehicle compartment upon completion of the modification work.

**Fig. 4** Vehicle interior after finish modification work

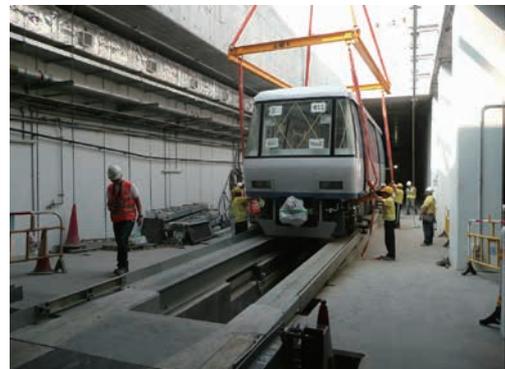
**Fig. 5** Delivery of a new vehicle

On the other hand, there was possibility to work on the new line and the extensions of the existing lines without having to worry about interfering with the service operation. In order to secure as much time as possible for running tests, we planned to perform some items of the test and commissioning only on the new line or the extensions of the existing lines wherever possible. New vehicles underwent a running test on the new line, in principle. **Figure 5** shows a photograph of new vehicle delivery work. **Figure 6** is a photograph of a vehicle undergoing a running test.

The new vehicles were fabricated at the Niigata Works of NTS and then upon completion of the guide rail installation work, they were delivered to the newly constructed depots in the extension areas.

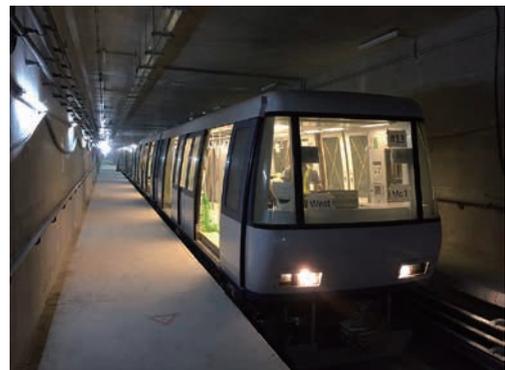
**Fig. 6** Test runs

For the extension of the existing lines, we took a special measure called Separate Track Test, in which a running test was conducted only on the extensions. This measure divided each track into three areas: an operating area, a test area, and an isolation area located between the operating and test areas to prevent the vehicle running in the operating area from entering the test area and vice versa. Track end buffers that had been installed since before the track extension work at the end of operation area were left unremoved, and the traction power feeder line in the isolation area was de-energized. At the end of test area, temporary track end was also added to the track database of the new signaling system. In addition, additional temporary stations (stop positions)
