# Repair Project of Existing Suspension Bridges for Long Lifespan

Large scale suspension bridges are very important infrastructures for supporting national economic activities. However, recently regarding suspension bridges that were built more than 30 years ago, the decline in durability due to local damage from aging is a concern. Since replacing suspension bridges is very costly, it is common and reasonable to try prolonging bridge lifespans by repairing and reinforcing the damaged part of the bridge. Against this backdrop, projects involving existing suspension bridges for the purpose of increasing the lifespan have been increasing. This report describes three major projects carried out by IHI Infrastructure Systems Co., Ltd. worldwide.

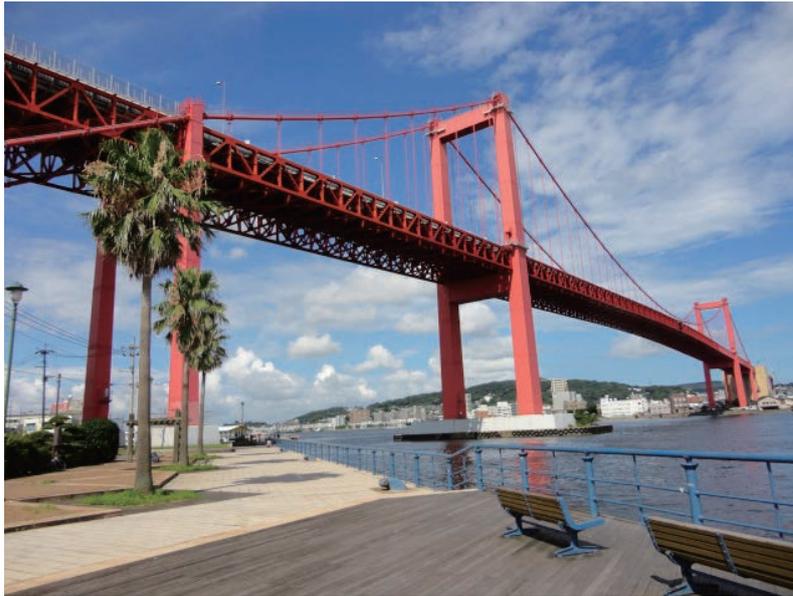
Fig. 1 Panoramic view of “Wakato Bridge”

day, with a cumulative total for the past 57 years exceeding 600 million vehicles. **Figure 1** provides a panoramic view of the “Wakato Bridge” and **Fig. 2** provides a general drawing of the bridge.

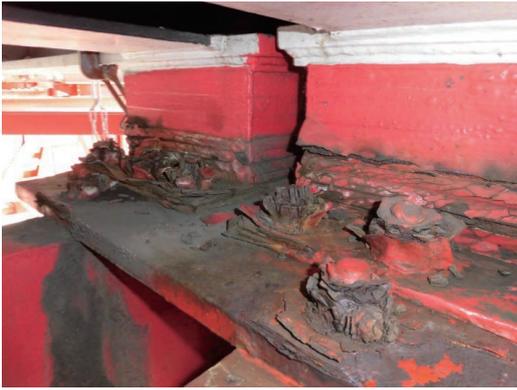
Fig. 4 Corrosion condition at upper chord of floor truss

As illustrated in **Fig. 3**, one block of the orthotropic steel decks was supported by a floor frame structure consisting of six continuous spans (25-m blocks), and the bearings are located on the floor truss upper chords. The entire suspension bridge was comprised of 25 orthotropic steel deck blocks, with a rubber expansion joint located between each block; however, these rubber expansion joints frequently became damaged due to heavy traffic. Damaged rubber expansion joints leaked water, advancing the corrosion of the floor truss upper chords as well as contributing to early deterioration of the asphalt pavement. Thus, it was necessary to implement asphalt pavement replacement every 20 years. **Figure 4** shows the corrosion of a floor truss upper chord.

Moreover, damage to the rubber expansion joints also contributed to noise and vibration that affected the surrounding areas, making it an issue in maintenance and

management. In order to eliminate these issues, several works were executed in this project, including: ① continuation of the orthotropic steel decks; ② reinforcement of the floor truss upper chords; ③ replacement of the anchor bolts for the

In order to improve the environment that caused water leakage resulting from damage to the rubber expansion joints leading to corrosion, as mentioned above, it was decided to remove the rubber expansion joints, and continue the orthotropic steel decks. The continuation of orthotropic steel decks in this project was configured so that only the orthotropic deck plates between existing orthotropic steel deck blocks were connected by connection plates, rather than being configured to render the stringers or longitudinal ribs of adjacent blocks continuous with each other. Figure 5 illustrates the structure of the orthotropic steel decks after continuation, and Fig. 6 provides a side view of an orthotropic steel deck block joint.

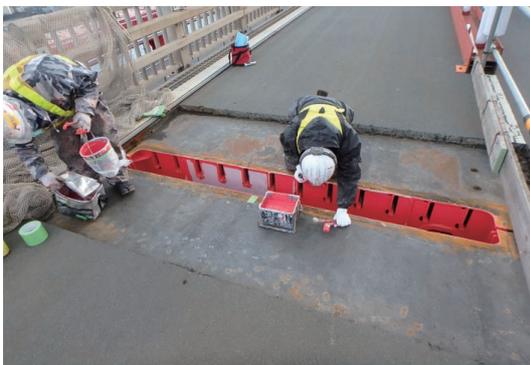
Fig. 7 Painting situation for joint of orthotropic steel deck

The asphalt pavement was dismantled beforehand and the rubber expansion joints were removed next. Since the orthotropic steel deck block joints were so close together you could not even put your hand between them, the joints were removed from the top surfaces of the orthotropic steel deck plates along with the ribs of the orthotropic steel decks in order to allow space for rust-proofing work, and then the joints were repainted. **Figure 7** shows repaint work being performed on an orthotropic steel deck block joint.

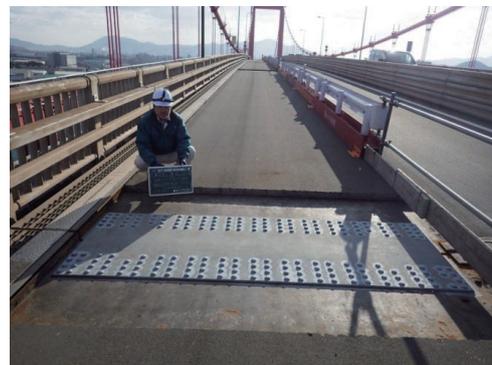
Fig. 8 Orthotropic steel deck continuation situation by new connection plates

The orthotropic steel deck continuation work was executed first on the driving lanes of the inbound and outbound lanes and then on each of their passing lanes. New connection plates were simultaneously installed at four panel points

— on the inbound and outbound lanes of the Tobata side, and on the inbound and outbound lanes of the Wakamatsu side — from the central part of the center span toward each anchorage in order to prevent the girder and orthotropic steel decks in service from being affected by temperature changes and from being subjected to overtight or overstress attributable to the live load. The orthotropic steel decks were then sequentially connected by using the new connection plates and high strength bolts to make them continuous. **Figure 8** shows the orthotropic steel deck continuation work being performed by using new connection plates.

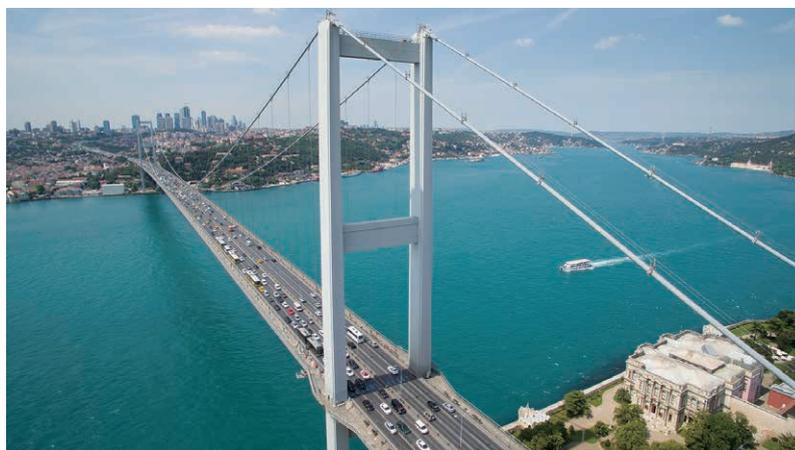
Fig. 9 Panoramic view of “Bosphorus Bridge”

The “Bosphorus Bridge” is a suspension bridge spanning the Bosphorus strait, which divides Istanbul, Turkey into eastern and western parts. Forty-six years have passed since its completion in 1973. **Figure 9** provides a panoramic view of the “Bosphorus Bridge.”

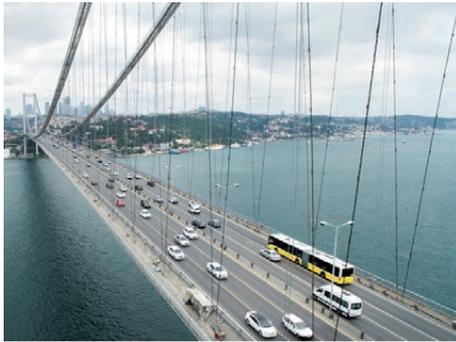
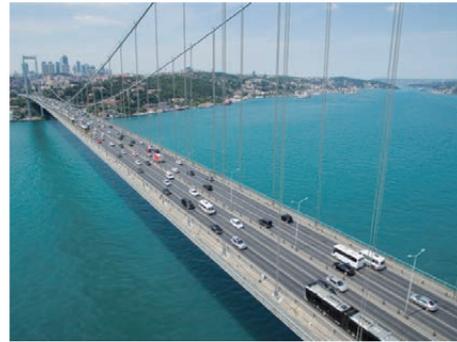
Fig. 12 Situation before and after dismantling inclined hanger

**Figure 11** illustrates the procedure that was followed to replace the inclined hangers with vertical hangers. Before the adoption of this method, PARSONS conducted a study on another method as well, whereby the original inclined hangers would have been replaced with new inclined hangers. Whereas this method required a 42-month work period because step ④ in **Fig. 11** was followed by two additional steps, i.e., the installation of new inclined hangers and the removal of vertical hangers, the adopted method was expected although a 20-month work period. The study resulted in the conclusion that the method of replacing the original inclined hangers with vertical hangers would be more economical and enable the works to be completed in a shorter period of time. For this reason, this method was adopted. Given that the traffic volume on this bridge was particularly high, the shortest duration of traffic restriction, one advantage of this method, was a key factor. **Figure 12** shows the situations before and after the removal of the inclined hangers.

(a) During works: Coexistence of inclined hangers and vertical hangers

(b) After works: Vertical hangers only

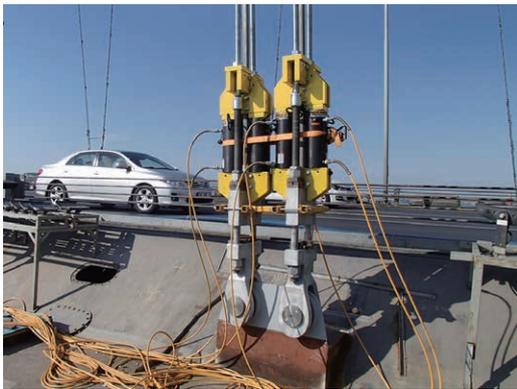
Fig. 13 Jacking equipment of hanger

hangers was approximately 500 kN, we conducted a structural analysis, thereby confirming that introducing this tension to each of the hangers would relieve the existing inclined hangers of tension. On site, the design tension was introduced to the vertical hangers by using tensioning equipment as shown in **Fig. 13**, and after tension had been introduced to all hangers, it was confirmed that the tension of inclined hangers

were almost completely released and then the inclined hangers were removed. After removal of the inclined hangers, the tension on the new hangers was measured again and it was adjusted at the panel points to be greater than the allowable limit, which is the design tension  $\pm 5\%$ . In addition, the tension was remeasured on the hangers adjacent to the hangers at the panel points on both sides, as they were also affected by the tension adjustments, and it was confirmed that the remeasured tensions were within the allowable limits. Thus, the inclined hangers were completely replaced.

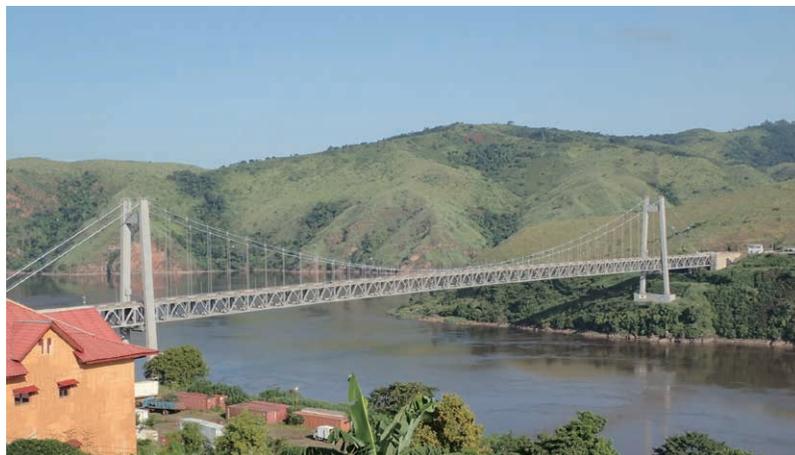
Fig. 14 Panoramic view of “Matadi Bridge”

The “Matadi Bridge,” situated in Matadi City, Congo Central Province in the western part of the DRC, was constructed by a JV led by Ishikawajima-Harima Heavy Industries Co., Ltd. (the present IHI Corporation) with Japan’s loan assistance and was completed in 1983. It is a 3-span continuous stiffened suspension bridge with a bridge length of 722 m. **Figure 14** provides a panoramic view of the “Matadi Bridge” and **Fig. 15** provides a general drawing of the bridge.

Length of bridge	722 m
Span length	101 m + 520 m + 101 m
Width	11.5 m (one lane in each direction)
Year of completion	1983
