Development of a new evaluation method for the influences of catalyst fines on abrasive wears of marine diesel engines burning heavy fuel oil

T.Yamada, T.Fuji, and H.Ukai
Customer support department
Diesel United, Ltd.

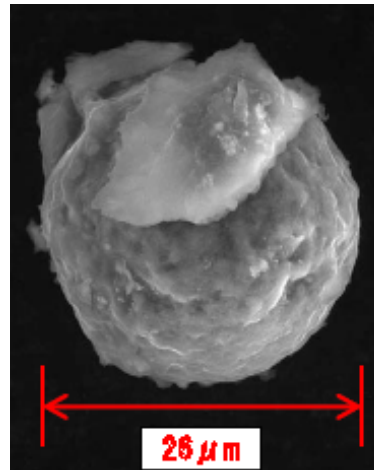
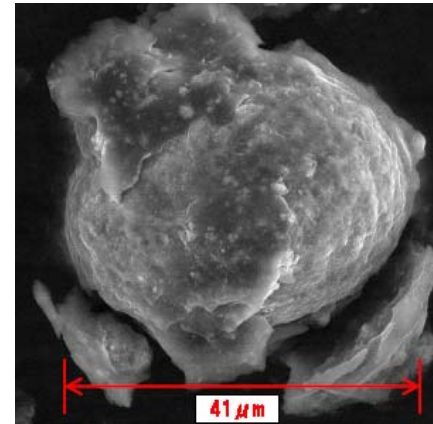
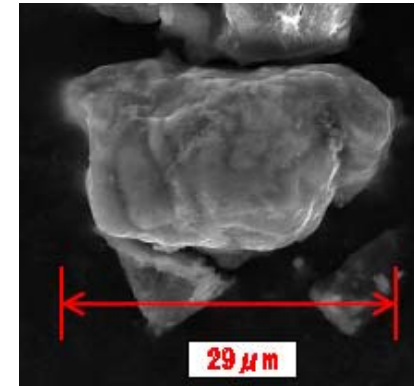
SEM
EDS

Case1. Hard particles in sample B HFO

We found some FCC catalyst fines and particles in the HFO.

Basis
components

-Al:8.3%/wt

-Si:13.9%/wt

-Al:17.5%/wt

-Si:7.7%/wt

Fe:31.6%/wt

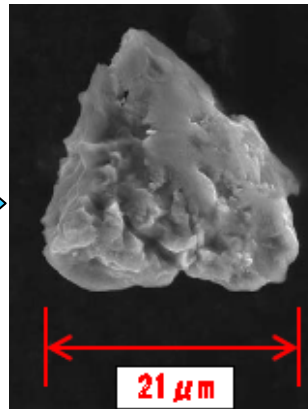
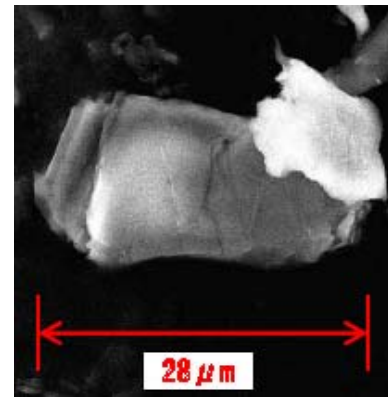
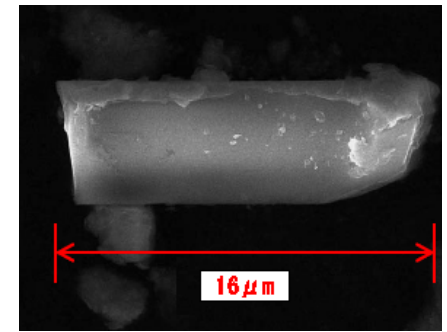
SEM
EDS

Case2. Hard particles in sample C HFO

We found some particles in HFO,
but **FCC catalyst fines weren't found.**

Fe:36.8%/wt

-Mg:11.6%/wt

-Si:17.1%/wt

-Ca:9.2%/wt

-Si:14.6%/wt

The example shows that **not only FCC catalyst fines but also hard particles in HFO can cause abrasive wear.**
