# Report on Rehabilitation Project of the “Binh Bridge” in Vietnam

“Binh Bridge,” located in Hai Phong City, Vietnam, is a cable-stayed bridge with composite girders that was completed in 2005. In July 2010, parts of the main girder and several stay cables of the bridge suffered serious damage after three ships washed away by typhoon No. 1 collided with it. Rehabilitation works on the bridge were awarded to IIA in March 2012 following a collaborative emergency investigation within the IHI Group (IHI, IIS, IIA). This is the first time IHI undertook cable replacement works and the complex stress distributions in the composite girder necessitated extensive planning. This report describes the rehabilitation works carried out on the bridge, in particular the main girder repair and stay cable replacement.

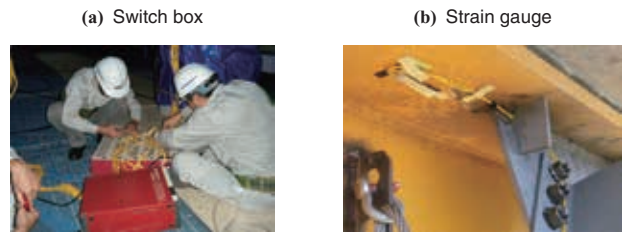
Fig. 15 Measurement of strain

In order to compare the actual stresses with those calculated for design, we attached a uniaxial strain gauges to the upper and bottom flanges of the main girder and the TB truss and measured the stresses and strains at each construction stage to confirm safety. **Figure 15** shows the strain being measured. We also measured the elevation of the main girder at each major construction stage to confirm that no abnormal values were observed.

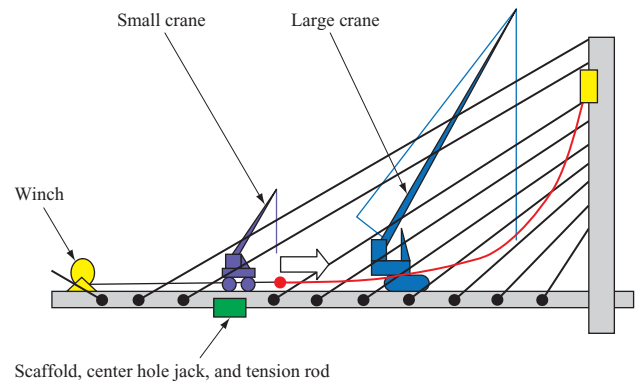
Fig. 20 Unorthodox cable installation procedure

Figure 20 shows the arrangement of equipment that was to be used for cable removal by following the cable installation procedure in reverse as planned at the early stages of the project.

However, this method would require a large crane for removing sag and a crane for removing the cable socket on the girder side to be placed on the girder. A winch would also be required for towing the cable horizontally. In addition, although the sag-removing crane could serve as a substitute, another crane would also be required for bringing the cable down after the socket on the tower side had been removed.

In addition, since the third and fourth cables from the top needed to be replaced in this construction, sound cables would still be in place above the cables to be replaced. Accordingly, for sag removal and removal of the socket on the tower side, the upper cables would interfere with crane operation, so that construction would be impossible.

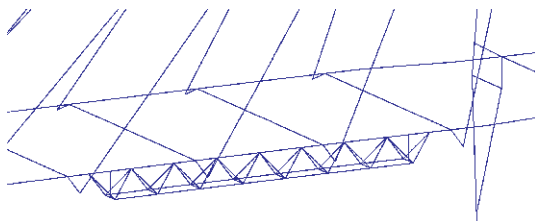
Fig. 23 Three dimensional frame model

the entire cable-stayed bridge. We used it to conduct a sequential analysis for examining fluctuating loads in each construction step to sum the section forces and evaluated the total section force. **Figure 23** illustrates the three-dimensional frame model.

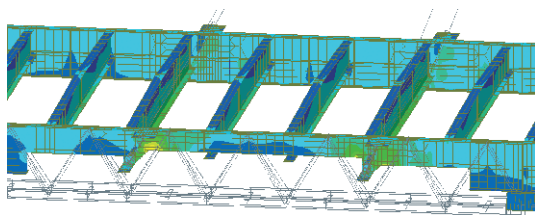
Fig. 24 FEM Model for checking local stress

The local influence of factors such as the shape of the cut-away portion of the girder, and the structural influence of factors such as the effective width of the slab, cannot be accurately taken into consideration by performing only a stress check based on section forces obtained by the frame analysis. Accordingly, for the replacement portion of the girder, we also designed a Finite Element Method (FEM) model with consideration given to cable anchorages and the TB truss and applied the section force obtained from the above frame model to the FEM model to evaluate local stress intensity. In this process of using the FEM model, we also simulated the sequential steps to confirm safety. **Figure 24** illustrates the FEM model.

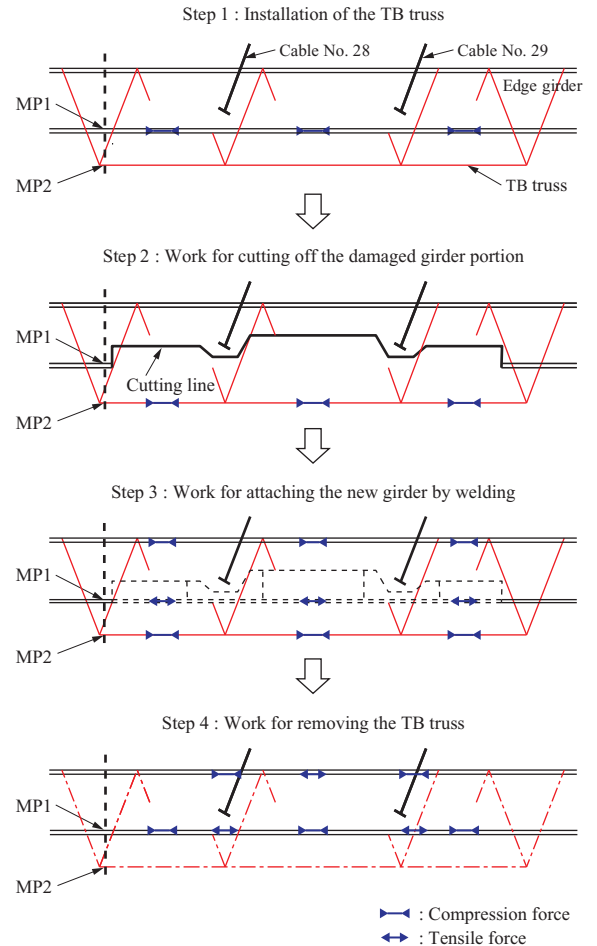
Fig. 25 Stress monitoring for each construction step

**Figure 25** outlines forces exerted on the bottom flange and the bottom chords of the TB truss during the repair work. **Figure 26** shows monitoring results at monitoring points 1 and 2. The vertical axis denotes the magnitude of acting forces, and the horizontal axis denotes the steps

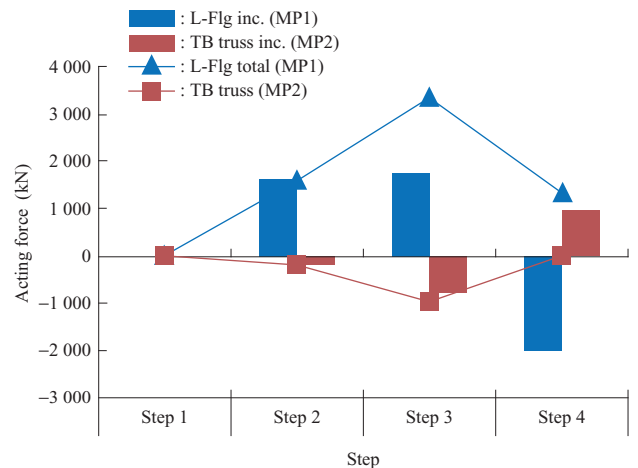
Fig. 26 Force changes during construction

of the repair work. The vertical bars show variations in forces exerted on the bottom flange and the bottom chords of the TB truss in each step, and the polygonal line graphs indicate the accumulated totals of the variations.

When the bottom flange that had been deformed in out-of-girder-plane direction was cut off, residual stress was released. Consequently, the main girder exhibited behavior that seemed to reduce its out-of-plane deformation. The stress monitoring also observed a stress difference due to out-of-plane deformation between the upstream and downstream bottom chords of the TB truss. Measured values seen in **Fig. 26** are the averages of stress values measured at the upstream and downstream bottom chords of the TB truss. These measured values were obtained by subtracting stress due to out-of-plane deformation.
