# Initiatives for and a Case Study on Maintenance Work for Metropolitan Expressway Bridges

**KAJIMA Kenji** : Deputy General Manager, Urban Expressway Department, Bridge Engineering Division, IHI Infrastructure Systems Co., Ltd.

**MIYATA Akira** : General Manager, Urban Expressway Department, Bridge Engineering Division, IHI Infrastructure Systems Co., Ltd.

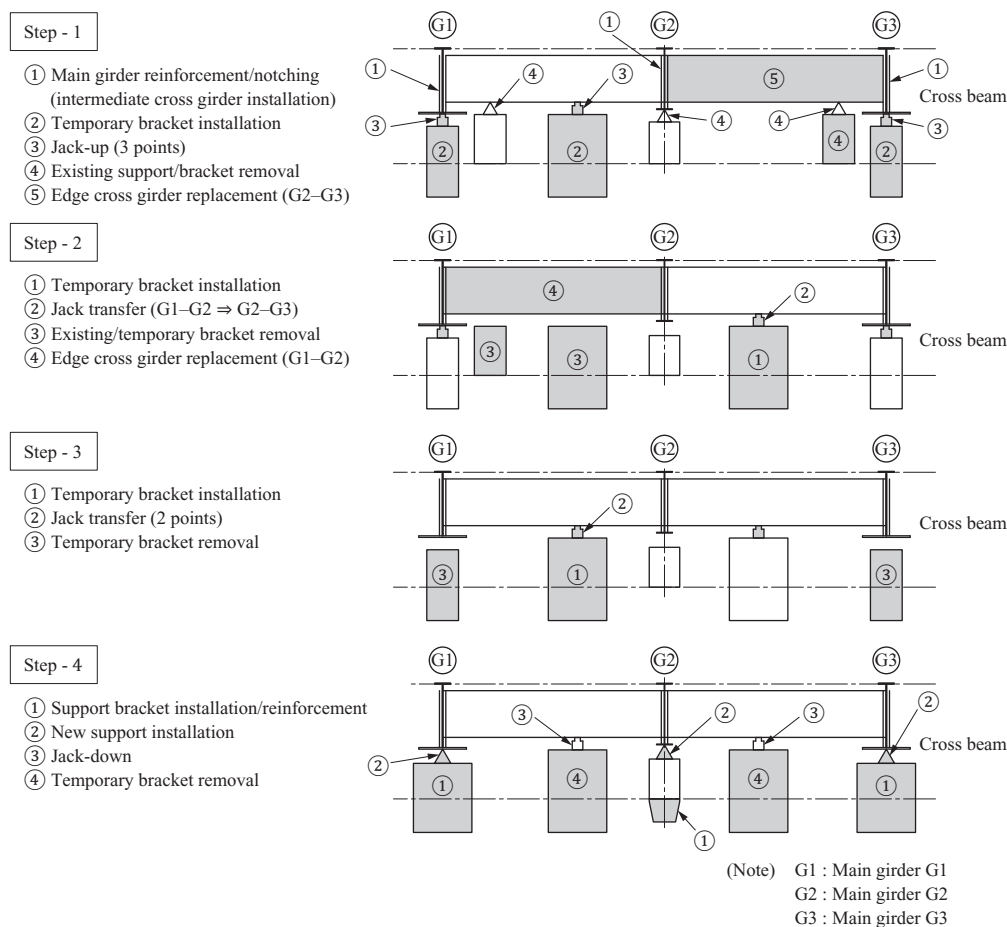
Fig. 5 Jack-up position moving method

Due to the completed system designed to have bridge supports and support brackets immediately below the main girders, it was difficult to determine jack positions for bridge support replacement, the component layout during temporary installation and during final installation, and component replacement procedures. We therefore conducted various studies and decided to adopt a method that allowed component replacement as well as repair and reinforcement works to be performed while the jack height is adjusted for each step of the works, and that allowed the final installation of bridge supports directly below the main girders. **Figure 5** shows the jack position moving method. Moreover, edge cross girders were also replaced out of consideration for maintainability.

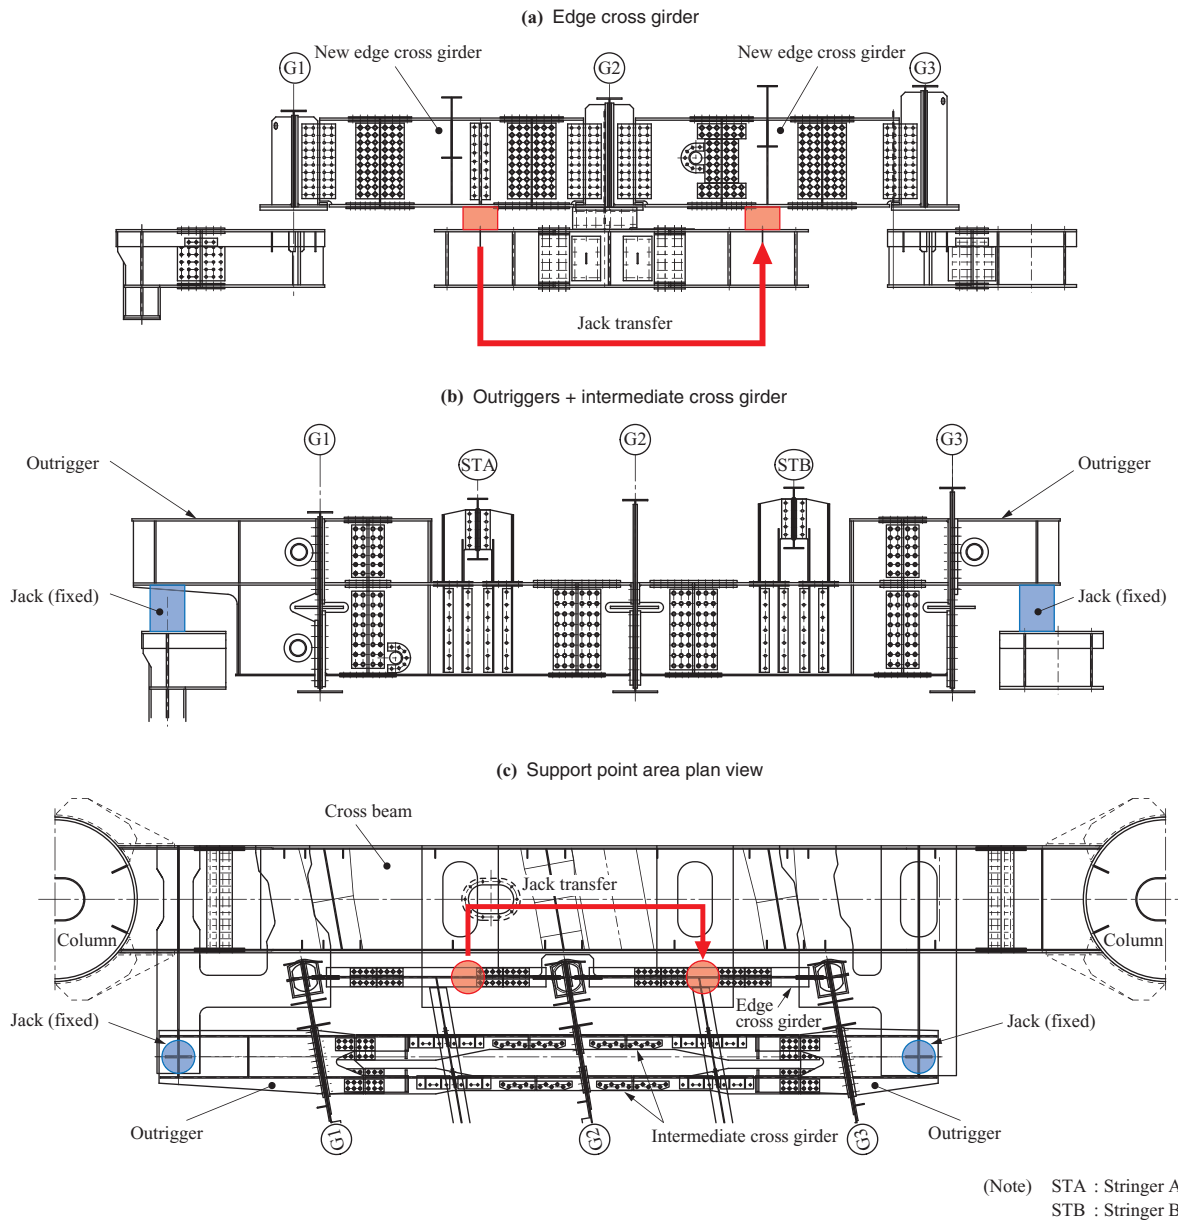
Fig. 6 Outrigger installation method

The method described in (1) above involves support point transfer, which contributes to there being a large number of steps. For this reason, improvements including reducing the number of steps and simplification of the reinforcing materials were required at locations on an expressway or street where traffic control was implemented. We therefore improved this method to be able to perform jack-up by installing outriggers outside the outer girders (G1, G3) (and an intermediate cross girder between main girders). **Figure 6** shows the outrigger installation method. Among the three jack-up points, two at the bottoms of the outriggers (one per outrigger) were fixed and the remaining one was transferred from the G1–G2 section to the G2–G3 section, which allowed us to continue the work.

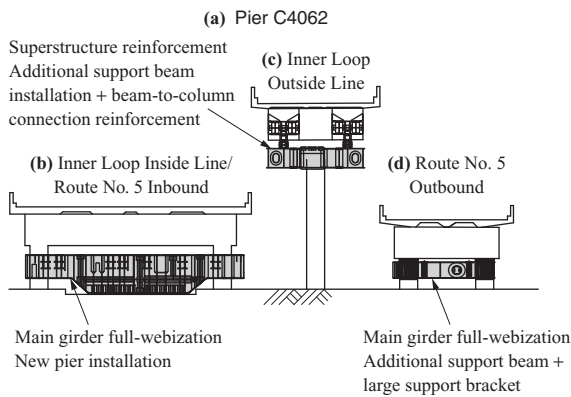
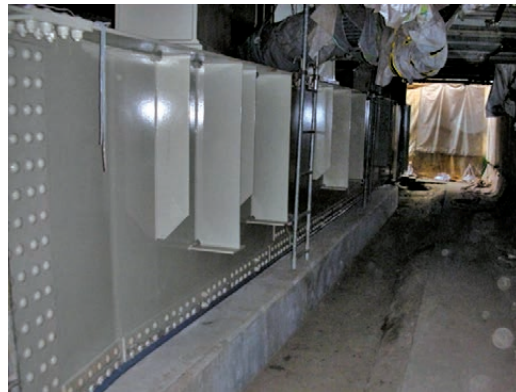
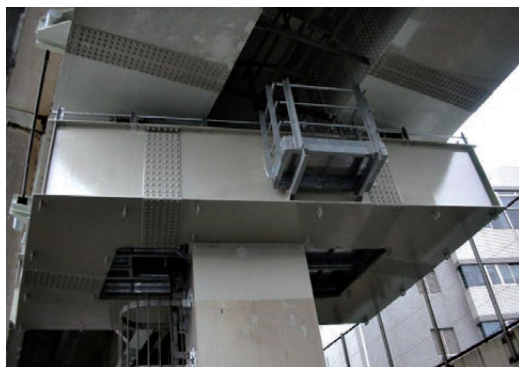
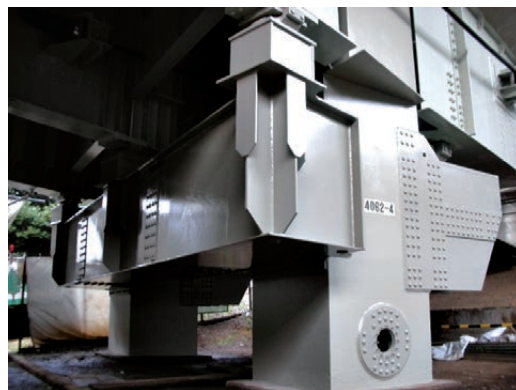
**Fig. 9** Pier C4062 : Special reinforcing structure

**Figure 9** shows the special reinforcement structures at C4062, which is comprised of three piers: one for Inner Loop Inside Line and Route No. 5 Inbound (low-profile portal pier) as shown in **Fig. 9-(a)**; another for Inner Loop Outside Line (rigid coupling with a box girder on one side and support by an I-section plate girder on the other side) as shown in **Fig. 9-(c)**; and the remainder for Route No. 5 Ikebukuro Line (Outbound) (portal pier supported by a box girder on one side

and by an I-section plate girder on the other side) as shown in **Fig. 9-(d)**. We determined the reinforcement structures taking into account the characteristics of the respective existing structures, damage situations, and work site conditions. **Figure 9-(b)** shows an additional steel pier installed between existing columns and integrated with them to support the superstructure. **Figure 9-(c)** shows a special additional support beam bolted only on the column web, which was adopted due to the rigid structure on only one side formed by the reinforcement structure along with the main girder. **Figure 9-(d)** shows a reinforcement structure on one side of

which discrete large support brackets were adopted as columns supporting a box girder and on the other side of which an additional support beam was adopted.

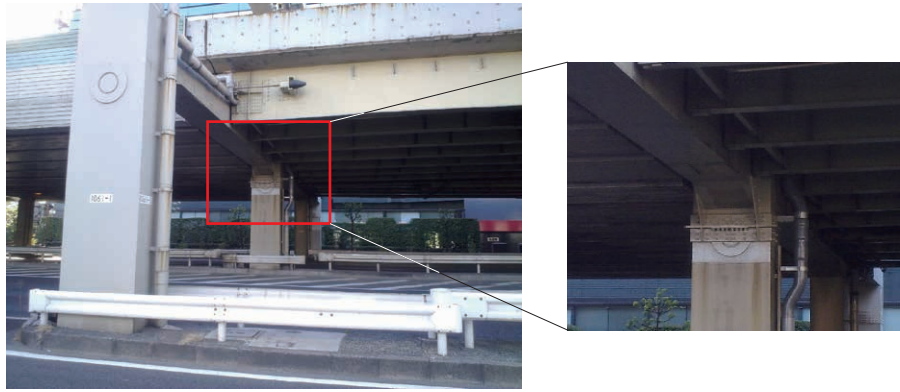
Fig. 12 Special reinforcement at beam-to-column connection

For a special beam-to-column connection area, where a column and a cross beam of two different widths cross each other, we adopted a reinforcement structure consisting of a stiffening plate and a member wrapped around the pier for reinforcement. Figure 12 shows reinforcement of the special beam-to-column connection. Although the reinforcement dimensions were maximized to the extent possible under the

restrictions, a stress reduction rate of 50%, the guideline for reinforcement, could not be achieved.

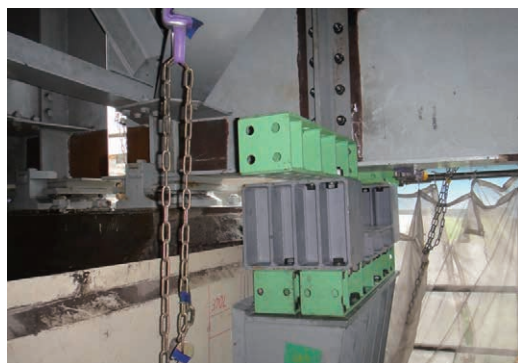
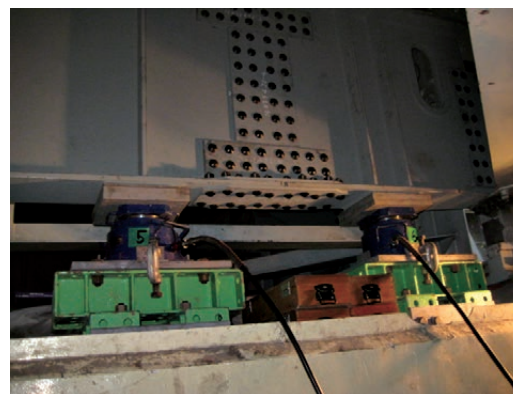
Fig. 14 Jack-up method

Method ①: Jack-up bracket method (Fig. 14-(a))

Method ②: Edge cross girder jack-up method (Fig. 14-(b))

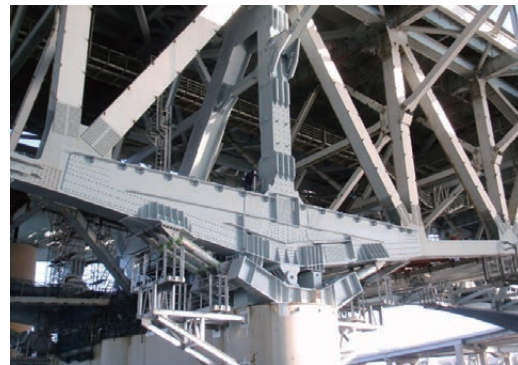
Fig. 20 Reinforcement at bridge support

In the basic design phase, we planned to install dampers in movable support point zones to reduce the response of the entire bridge to earthquakes and to reduce the load acting on the substructure. As a result of our study conducted during the project, however, it was found that dampers installed at the movable parts of suspended girders of the cantilever truss would work effectively. For this reason, we installed more dampers than originally intended, becoming able to reduce the number of stiffening plates. This contributed to reducing the cost of the reinforcement works.

Since the impact of bending moment in the support point zones was not negligible due to the large height of the supports, we conducted design taking into consideration such eccentric bending moment. Based on this design, large V-shaped stiffening plates were applied. In addition, dampers were installed in the movable support point zones. **Figure 20** shows a reinforcement for a support point zone. In this damper installation site, an inspection pathway for use in maintenance was also constructed.

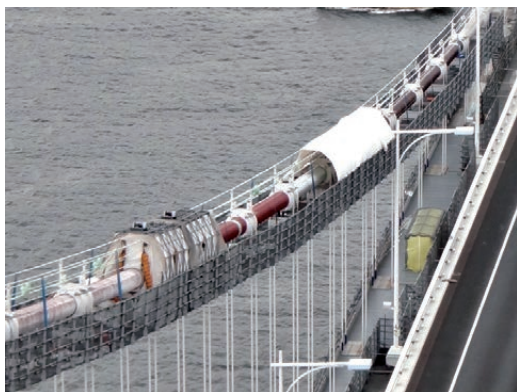
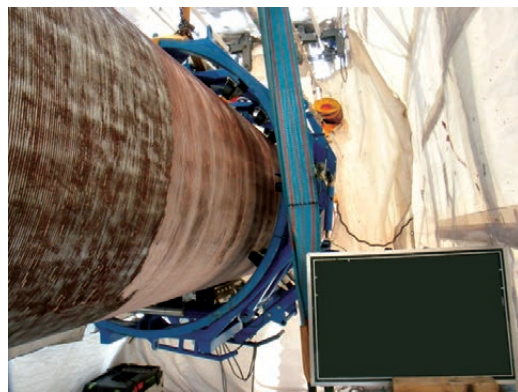
Fig. 24 Work status for dispersal prevention equipment

Since the existing coating contained a lead component, lead poisoning countermeasures were implemented for surface preparation. Surface preparation and painting operations were performed in dispersal prevention equipment. Figure 24 shows the dispersal prevention equipment and the painting operation. Since the dispersal prevention equipment had a

risk of being blown down by strong winds, it was erected and removed at the start and end of the operation on a daily basis. In order to reduce the effort for the surface preparation operation, we developed a simple scraping machine and utilized it in some locations.
