Locating Damage Source in High Pressure CFRP Gas Tank for Space Rocket using AE Measurement

We have been studying damage evaluation methods during the hydraulic test of the thin-walled CFRP pressure vessel using three-dimensional source location (3D source location). In this study, we conducted 3D source location using water propagation waves when the CFRP pressure vessel was damaged. Also, we evaluated the separation tendency of surface propagation waves and water propagation waves, thereby confirming the Kaiser effect. In order to improve the precision of 3D source location using water propagating waves, we demonstrated a new method, "Area locating." The results thereof confirmed that 3D source location using "Area locating" was consistent with fracture phenomenon. In addition, the new method was able to identify the origin of the fracture.

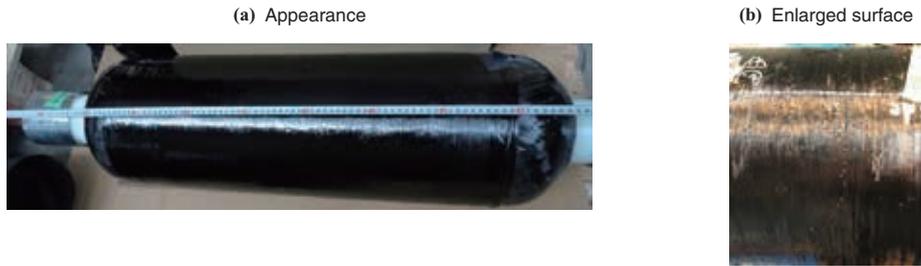
Fig. 1 Thin-walled CFRP pressure vessel

Figure 1 illustrates the thin-walled CFRP tank, in which the appearance and enlarged surface are respectively illustrated in **Figs. 1-(a)** and **-(b)**. The specifications of the tank are listed as follows. Note that the proof pressure refers to a pressure value up to which a manufacturer of the tank guarantees the soundness of the vessel, but not to a pressure

Carbon fiber winding thickness	6 mm
Dimensions	
Outside diameter	260 mm
Inside diameter	218 ± 2 mm
Total length	1 150 mm
Liner resin material	Polyethylene resin
Metal cap material	Aluminum 6061-T6 (JIS H 0001)
Proof pressure	7 to 8 MPa
Manufacturing conditions	
Helical hoop winding finishing of T700-compatible carbon fiber by a Filament Winder (FW) process → Full wrap winding processing on resin liner → thermal cure processing → After manufacturing, pressurization to proof pressure

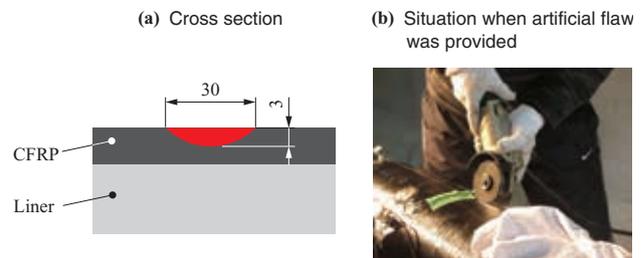
Fig. 3 Damage point (unit : mm)

Figure 2 illustrates the arrangement of sensors attached to the tank and a point of an artificial flaw. In this test, 12 sensors were used. Also, Figure 3 illustrates the artificial flaw formed by a grinder, in which the situation when the artificial flaw was provided is illustrated in Figure 3-(b).

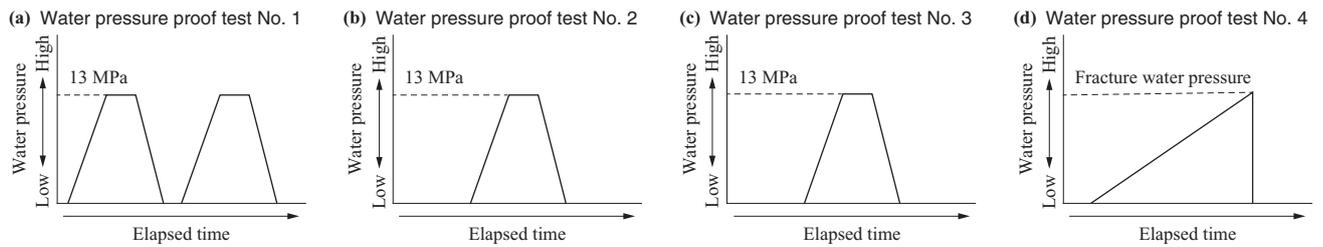
Fig. 4 Underwater propagation test

Figure 4 illustrates steps of the water pressure proof test. In the water pressure proof test No. 1, pressure was raised to 13 MPa twice. Subsequently, the artificial flaw was added on the tank, and then in each of the water pressure proof tests Nos. 2 and 3, pressure was raised to 13 MPa once. Finally, in the water pressure proof test No. 4, pressure was raised until the tank was ruptured.

(Note) (b), (c) and (d) illustrate the steps of the water pressure proof test after providing the artificial flaw.

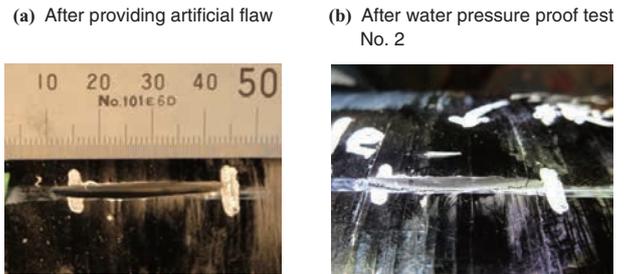
Fig. 6 Change of damaged point

Figure 6 illustrates the change of the damaged point between after providing the artificial flaw (-**(a)**) and after the water pressure proof test No. 2 (-**(b)**). From **Fig. 6**, it was confirmed that after the water pressure proof test No. 2, a crack occurred on the bottom surface of the artificial flaw point. It was also confirmed that the crack propagated from the edge of the artificial flaw point in the circumferential direction of the tank.

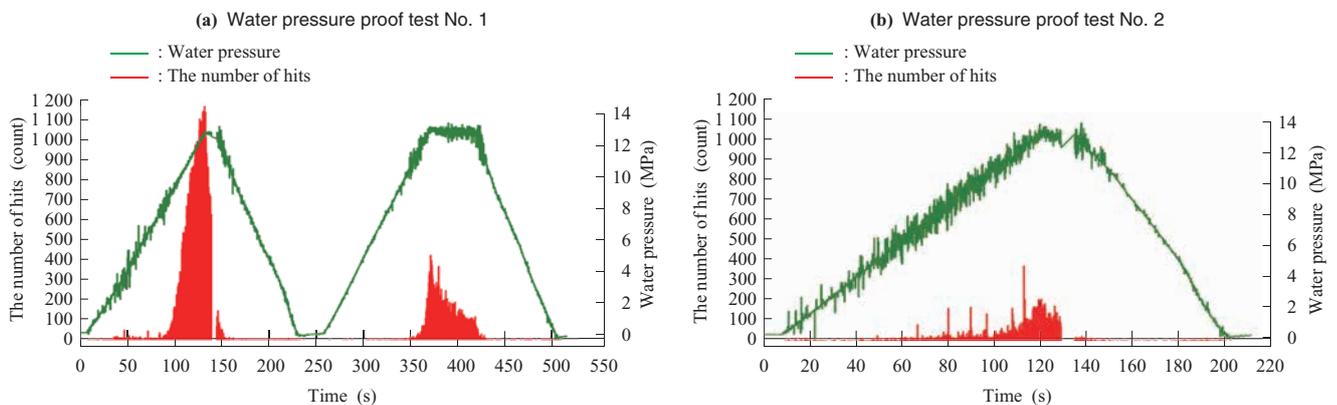
Fig. 5 AE hits per second

Figure 5 illustrates the numbers of AE hits per second in the water pressure proof tests Nos. 1 and 2. In **Fig. 5**, the green line represents water pressure. Also, the horizontal axis represents an elapsed time from the start of the test, the left vertical axis the number of hits, and the right vertical axis the water pressure. From **Fig. 5**, it was confirmed that in the water pressure proof test No. 1, the pressure was raised to 13 MPa twice, and in the second pressure raising process, no hit was found at up to 13 MPa, in other words, the Kaiser effect held. Note that the reason why AE hits were found at around 13 MPa (around 360 s) in the second pressure raising process was that the pressure was unstable and exceeded 13 MPa. In the water pressure proof test No. 2 after providing the artificial flaw, it was confirmed that hits were measured at 8 MPa or larger, and the Kaiser effect did not hold. This may be because in the pressure raising process to 13 MPa, a new crack occurred and the damage of the tank developed.

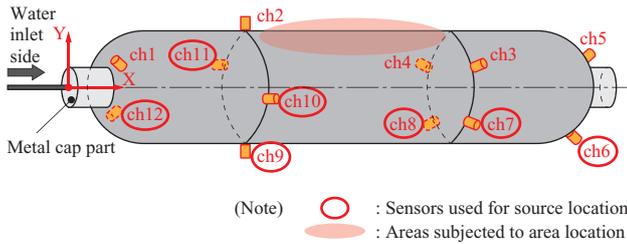
Fig. 7 Area location

For the three-dimensional source location described in this report, it is necessary to use only data on AE propagating under water. However, in AE data measured in this test, surface propagation waves and underwater propagation waves were mixed. Setting measurement conditions does not make it easy to measure only the underwater propagation waves, and the settings must be changed every time a measurement target is changed. For this reason, when performing the source location analysis after the measurement, both were separated. **Figure 7** illustrates area locating.

Each of the six areas described in the previous section was subjected to the source location by designated sensors. For example, the red area at the top of the tank illustrated in Fig. 7 corresponds to the area ③, which was subjected to the source location by the ch6 to ch12 sensors.

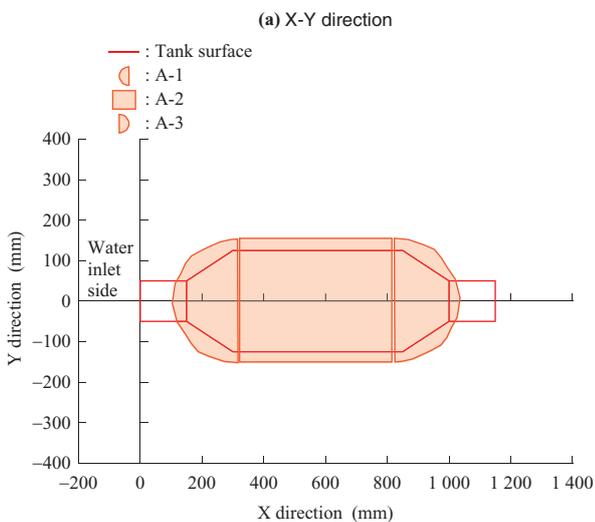
Fig. 9 Polygon processor

An area for the source location was determined using Visual AE software (by Vallen, Germany). Figure 9 illustrates a polygon processor. As viewed from the front Fig. 9-(a), the vessel was divided into three areas, whereas as viewed from the water inlet side -(b), it was divided into two areas. By

combining any two of the divided areas, a total of six areas (① A-1 and B-1, ② A-2 and C-1, ③ A-3 and B-1, ④ A-1 and B-2, ⑤ A-2 and C-2, and ⑥ A-3 and B-2) were defined. Figure 10 illustrates the six divided areas. This sort of source location method was referred to as area location.

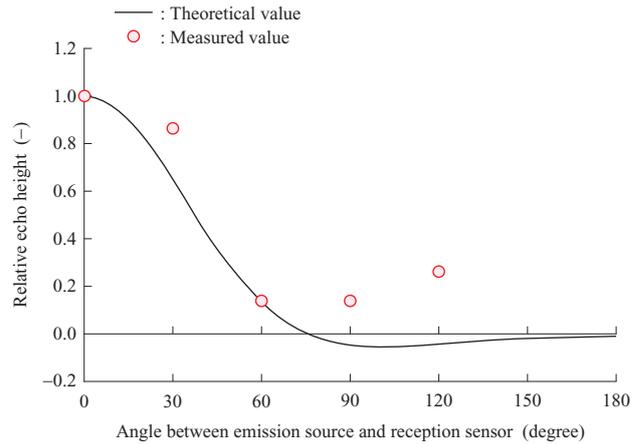
Fig. 8 Angle of source/receiving sensor and echo height

In order to determine reception sensors used for the analysis, it is necessary to take account of the directivity of the underwater propagation waves. Using VS150-RIC (oscillator diameter : $\phi 20$ mm) as an emission source and AE144A (oscillator diameter : $\phi 10$ mm) as a reception sensor, the relationship between the angle formed by the emission source and the reception sensor and relative echo height was calculated as a theoretical value. A reason to use VS150-RIC with $\phi 20$ mm as the emission source is that VS150-RIC is larger in oscillation diameter than AE144, resulting in high directivity, and therefore easily obtain the directivity of the underwater propagation waves. Figure 8 illustrates the theoretical value and measured value of the relative echo height with respect to the angle between the emission source and the reception sensor. From Fig. 8, it turns out that the measured value and the theoretical value both are close in value at up to 90° , and in particular, at up to 60° , have very close values. From this result, we thought that within the range where the angle between the AE emission source and the reception sensor is 0 to 60° , the underwater propagation waves can be obtained.

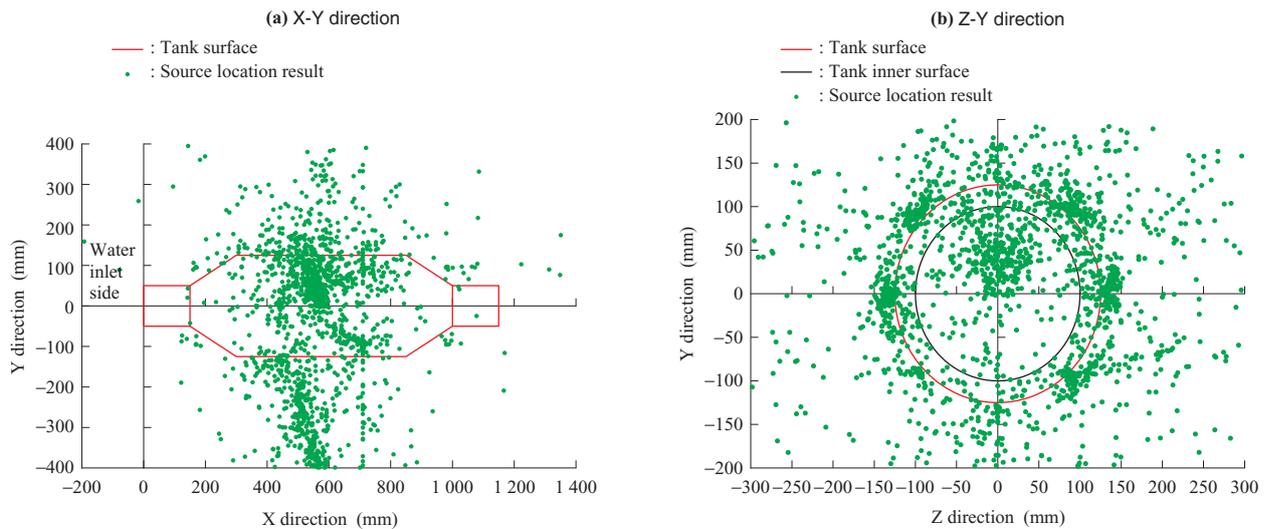
Fig. 11 3D source location using all AE data

dimensional source location based on all pieces of data and the results of the three-dimensional source location based on the area location. **Figure 11** illustrates the results obtained using the all pieces of measurement data without any area division, and **Fig. 12** illustrates the results based on the area location. **Figures 11-(a)** and **12-(a)** are plan views with the X direction as the horizontal axis, the Y direction as the vertical axis, and the water inlet side set on the left side. Also, **Figs. 11-(b)** and **12-(b)** are plan views as viewed from the water inlet side with the Z direction as the horizontal axis and the Y direction as the vertical axis. Green dots in these diagrams represent the source location results, and the positions of the dots represent AE emission sources.

From **Fig. 11**, it turns out that the location results are concentrated in the upper part of the tank. However, many results lie outside the tank and under water where no AE is supposed to occur. On the other hand, from **Fig. 12**, it turns out that the location results are not present both inside and

Figures 11 and 12 illustrates the results of the three-
